## Annual Inspection

Bentley Parish Council

Bentley Recreation Ground

School Lane , GU10 5JP

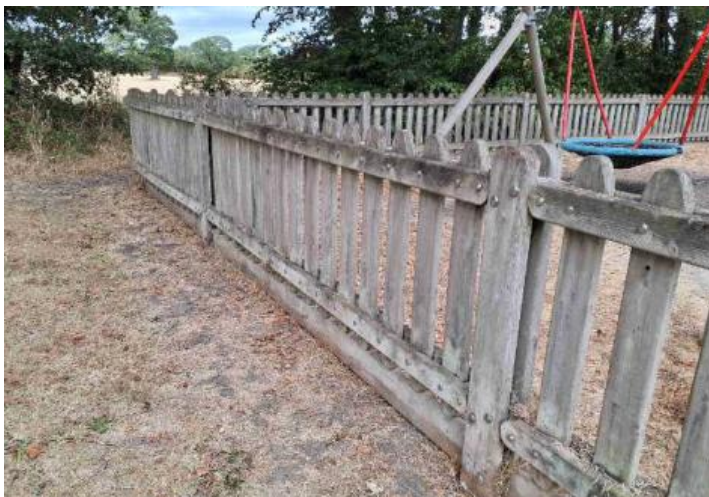
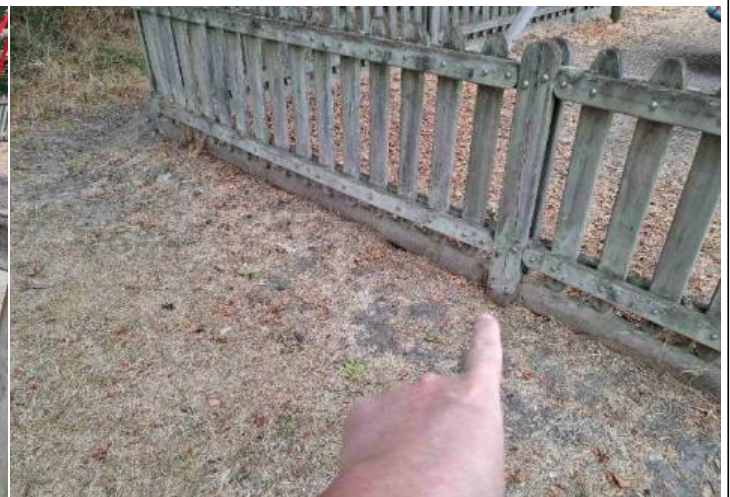
**Item:** Fences - Fencing - Timber  
**Manufacturer:** Jacksons Fencing

**Finding:** There are a number of loose posts around the fence

**Action:** Monitor for any further deterioration and reset as required

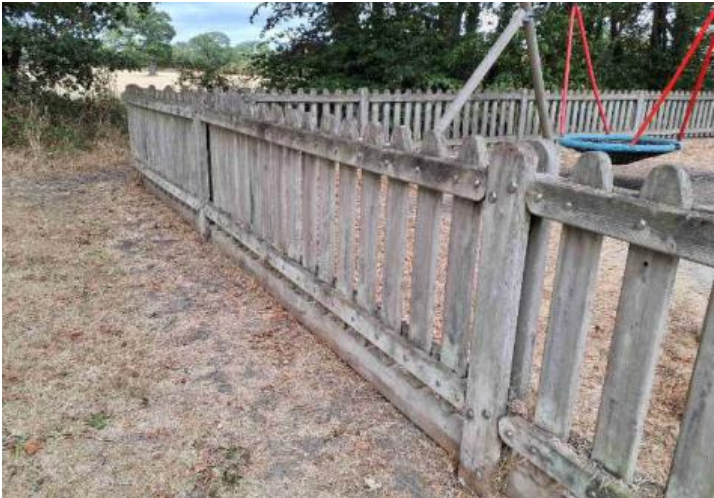
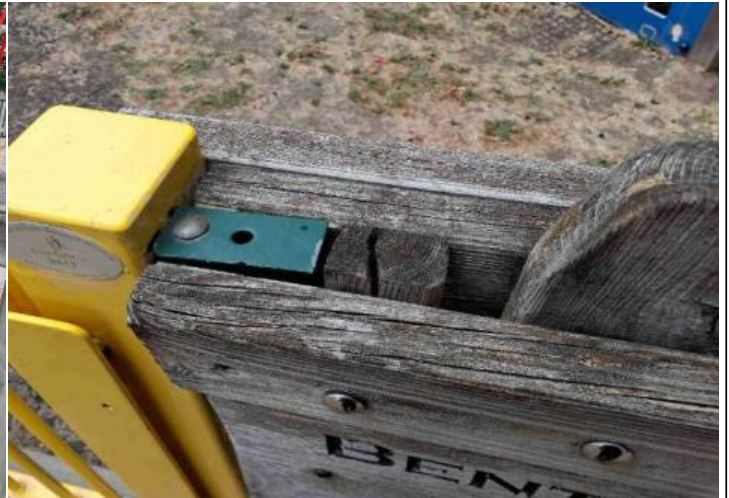
**Item:** Fences - Fencing - Timber  
**Manufacturer:** Jacksons Fencing

**Finding:** There is or are fixings missing on the item

**Action:** Replace all missing fixings

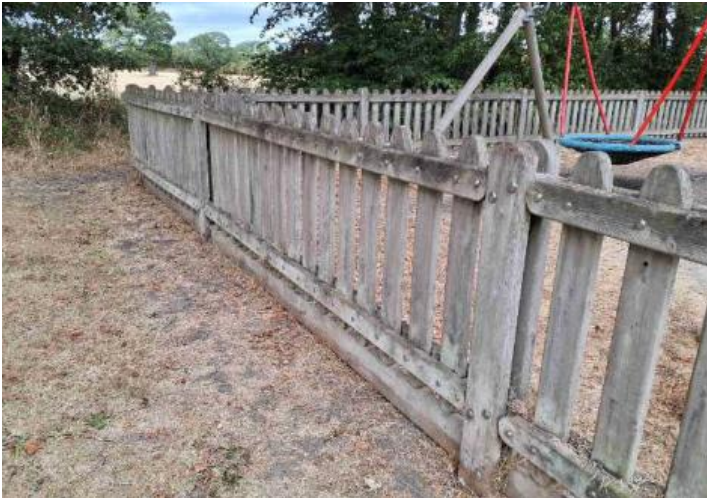
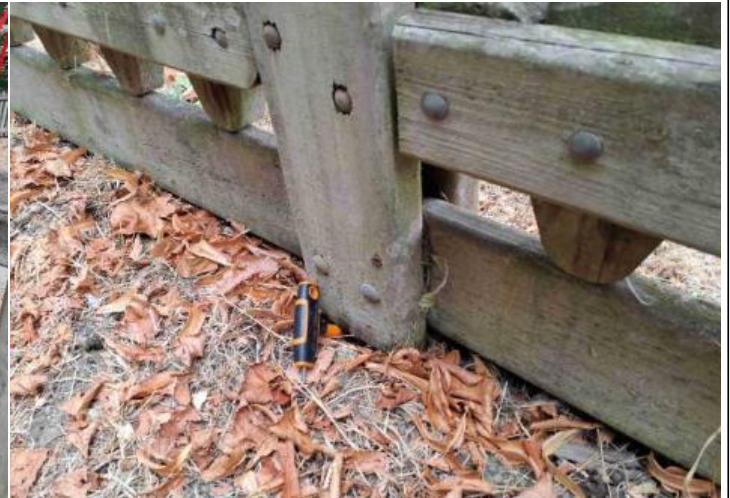
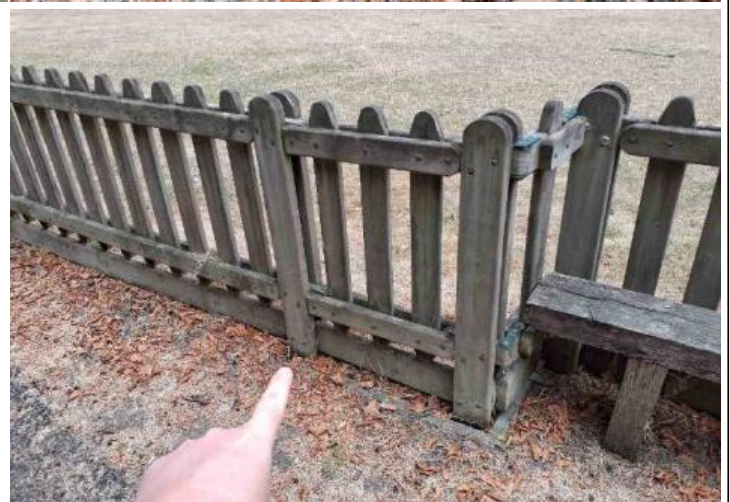
**Item:** Fences - Fencing - Timber  
**Manufacturer:** Jacksons Fencing

**Finding:** There are areas or parts of the timber posts that have rotted

**Action:** Replace all affected timbers

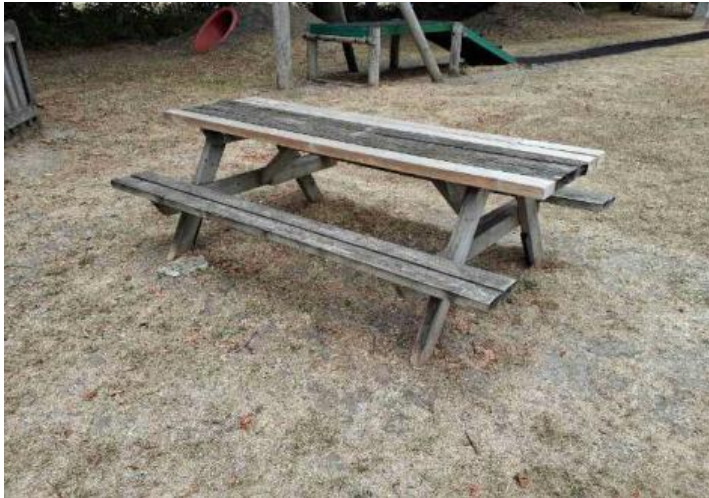
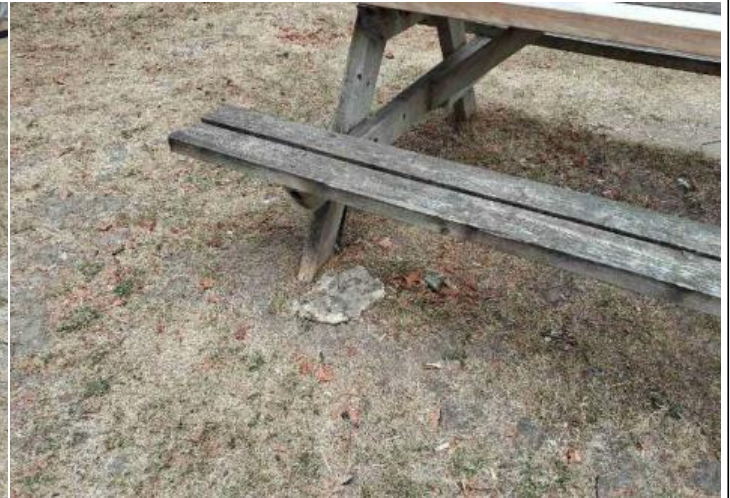
**Item:** Ancillary Items - Picnic Table  
**Manufacturer:** Not Identified

**Finding:** The surface has eroded and the foundations are exposed

**Action:** Reinstate surrounding surfaces to cover the foundations

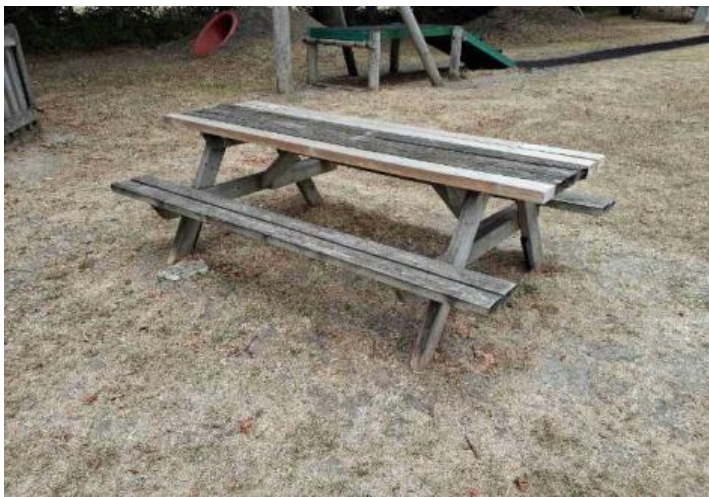
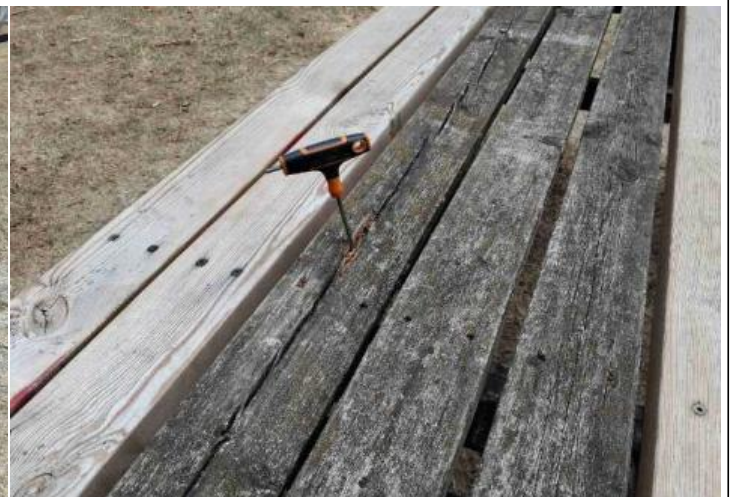
**Item:** Ancillary Items - Picnic Table  
**Manufacturer:** Not Identified

**Finding:** There is some evidence of rot in the timber

**Action:** Monitor for any further deterioration and replace as required

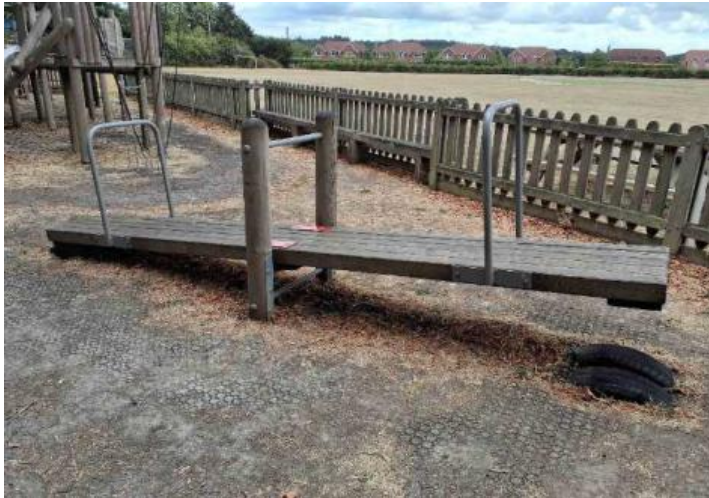
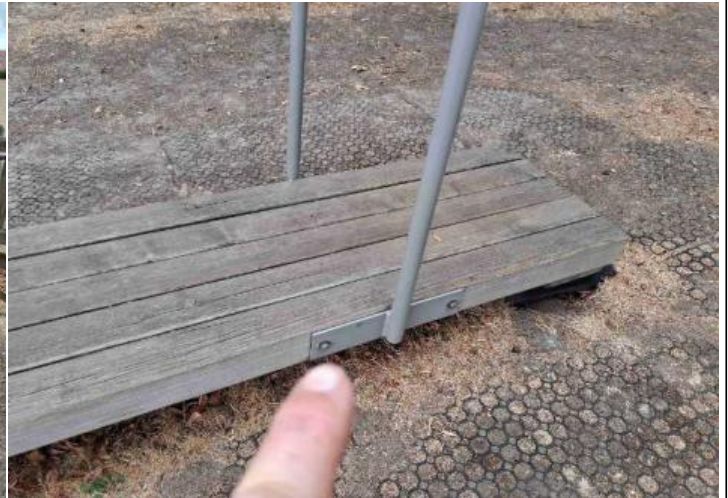
**Item:** Rocking Equipment - Stand up SeeSaw  
**Manufacturer:** Eibe Play Ltd

**Finding:** A number of fixing(s) have worked loose

**Action:** Secure all loose fixings

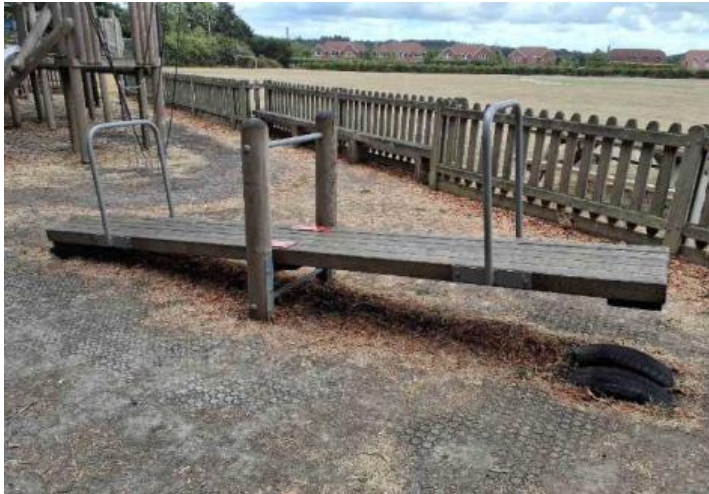
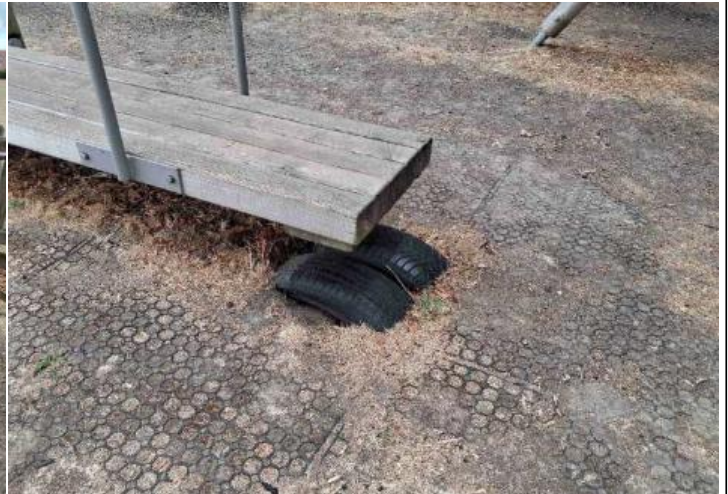
**Item:** Rocking Equipment - Stand up SeeSaw  
**Manufacturer:** Eibe Play Ltd

**Finding:** The surface has subsided around the tyre dampeners

**Action:** Monitor for any further deterioration and repair as required

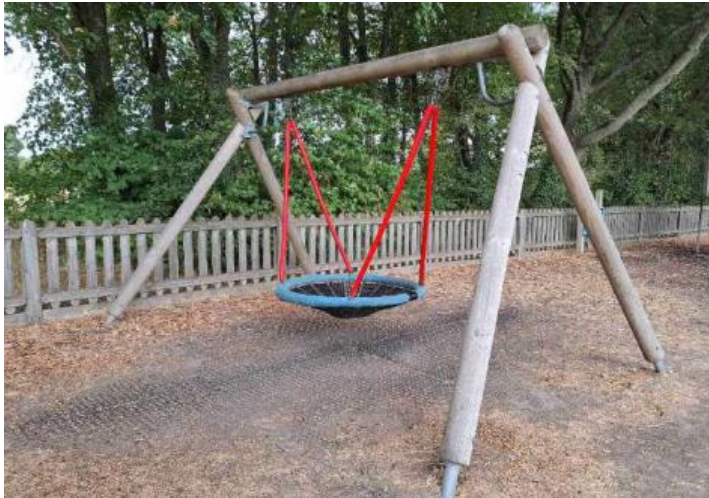
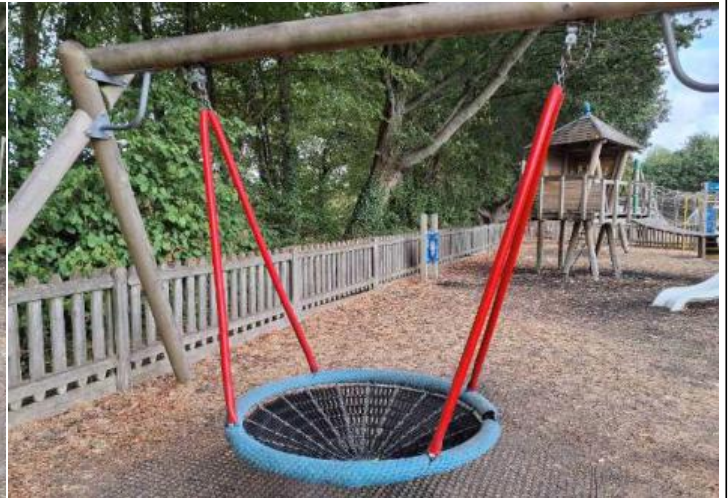
**Item:** Swings - Basket Swing - Type 1  
**Manufacturer:** Eibe Play Ltd

**Finding:** The seat connection cannot be inspected fully as the chain cover cannot be lifted

**Action:** Cut the cover to allow access to the shackle and assess the wear

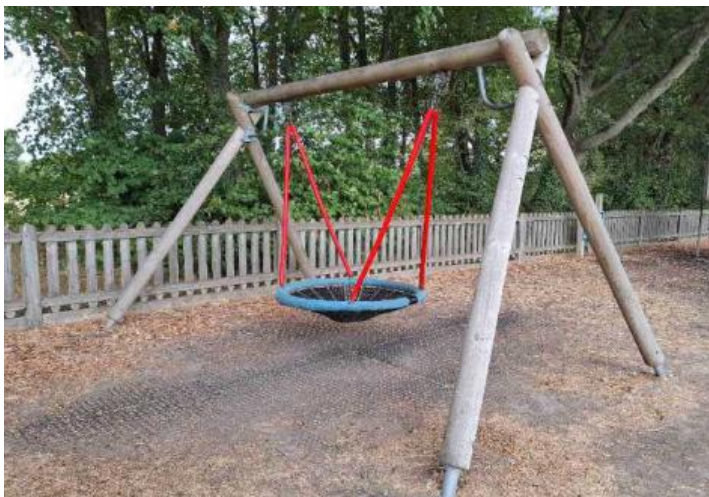
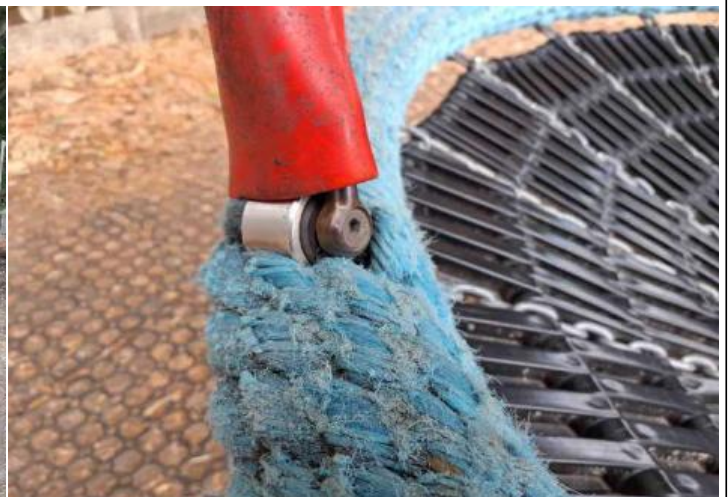
**Item:** Swings - Basket Swing - Type 1  
**Manufacturer:** Eibe Play Ltd

**Finding:** The bush / bushes is / are showing signs of wear

**Action:** Monitor for any further deterioration and replace as required

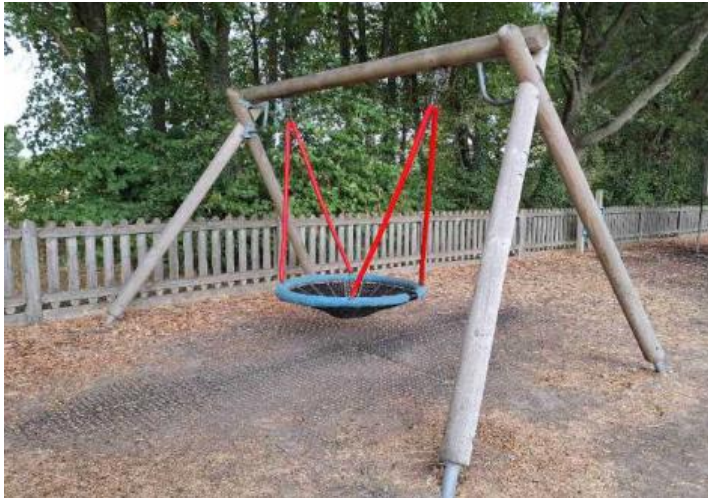
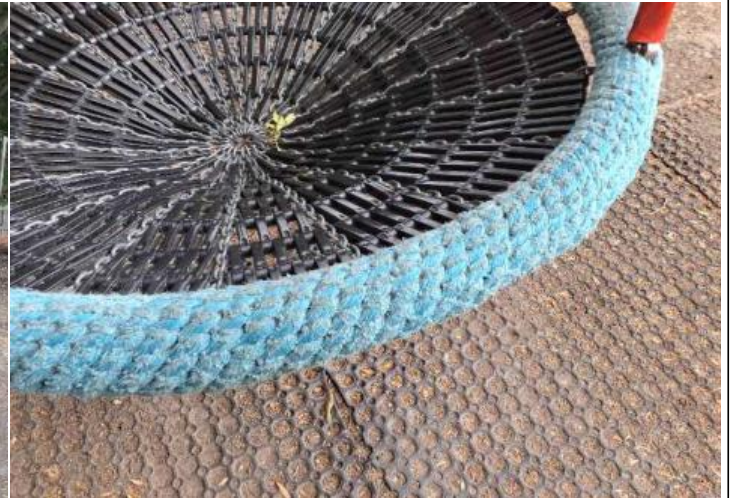
**Item:** Swings - Basket Swing - Type 1  
**Manufacturer:** Eibe Play Ltd

**Finding:** The ropes/nets are worn/damaged in places

**Action:** Monitor for any further deterioration and repair or replace as required

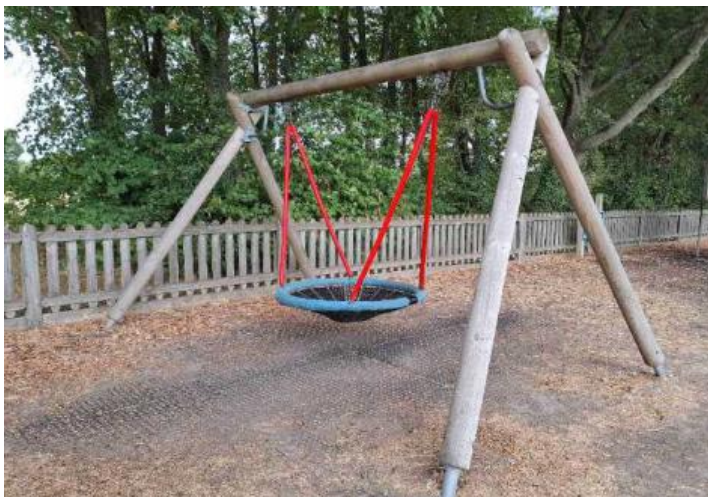
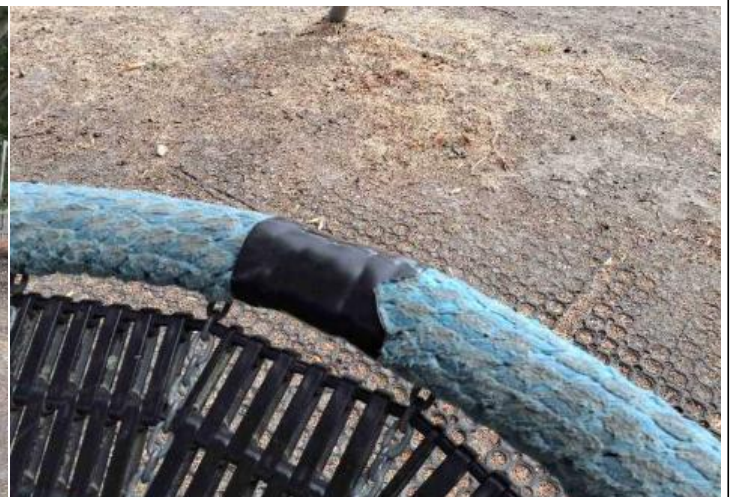
**Item:** Swings - Basket Swing - Type 1  
**Manufacturer:** Eibe Play Ltd

**Finding:** The seat has minor damage or wear

**Action:** Monitor for any further deterioration and replace as required

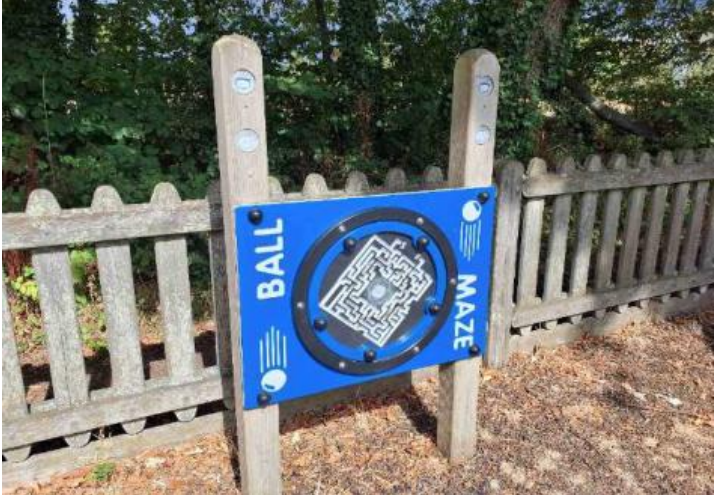
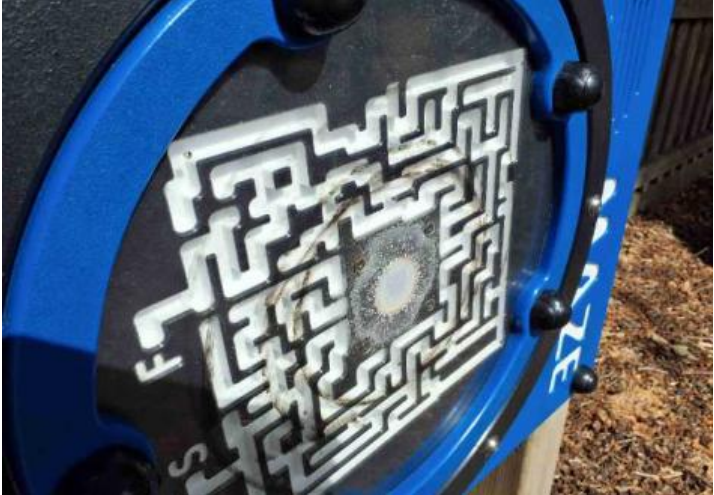
| <b>Item:</b> Activity Equipment - Play Panel | | <b>Risk Level:</b> L - Low Risk | |

| <b>Finding:</b> The item has been damaged | | <b>Action:</b> Monitor for any further deterioration and replace as required | |

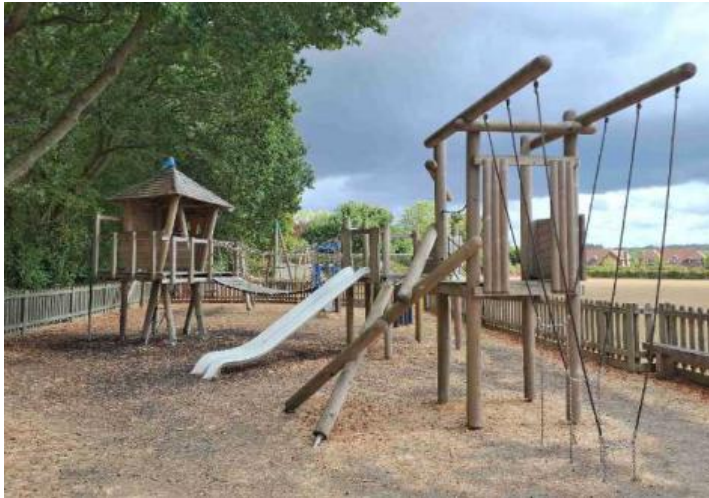
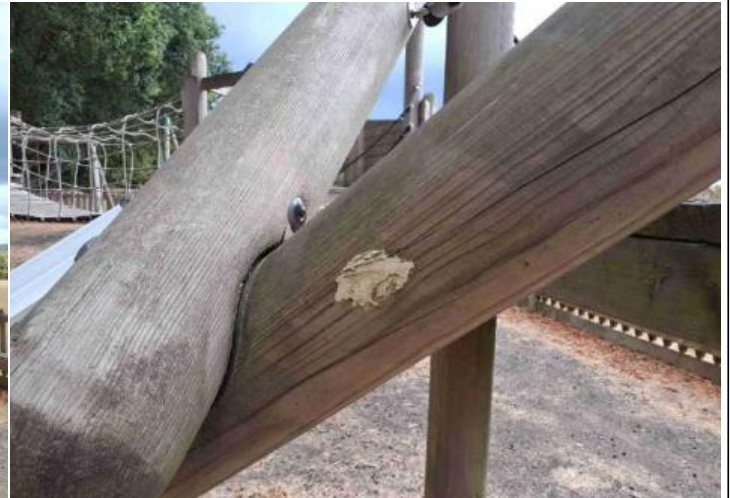
**Item:** Activity Equipment - Multi Play (Junior)  
**Manufacturer:** Eibe Play Ltd

**Finding:** The use of synthetic fillers in timber is not recommended; timber being a natural material will expand and contract as the moisture content changes and the use of fillers can exacerbate the length and depth of these cracks or shakes in the timber. The only treatment that is normally required is the removal of any rough or sharp edges unless the structural integrity of the item is affected.

**Action:** Remove any rough or sharp edges and monitor timber for any further deterioration

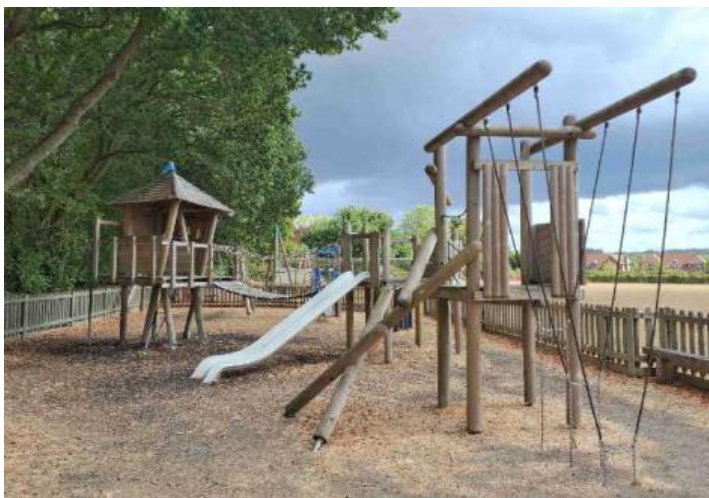
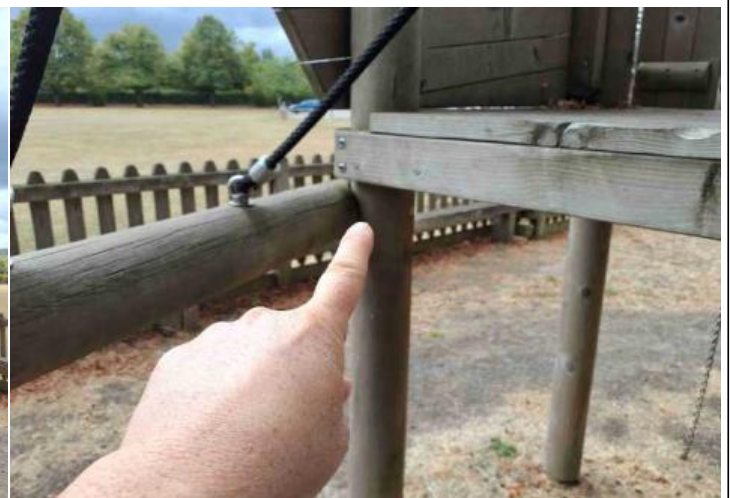
**Item:** Activity Equipment - Multi Play (Junior)  
**Manufacturer:** Eibe Play Ltd

**Finding:** A number of fixing(s) have worked loose

**Action:** Secure all loose fixings

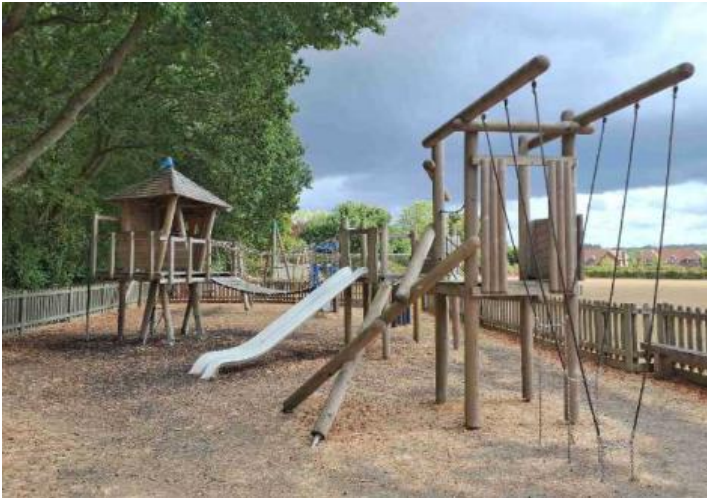
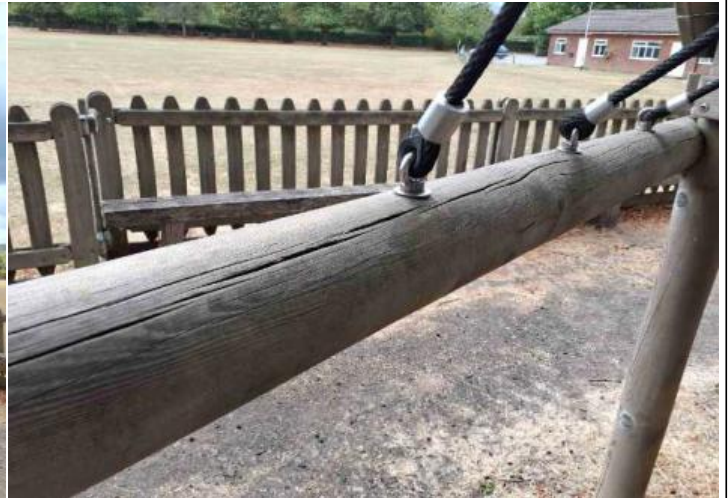
**Item:** Activity Equipment - Multi Play (Junior)  
**Manufacturer:** Eibe Play Ltd

**Finding:** The timber has a number of splits/shakes or air cracks and this may affect the stability or allow water ingress which will accelerate the rotting process. Timber splits may also create rough / splintering edges.

**Action:** Monitor, sand down any rough edges and ensure the splits do not cross through fixing points of the structure and/or cause any instability

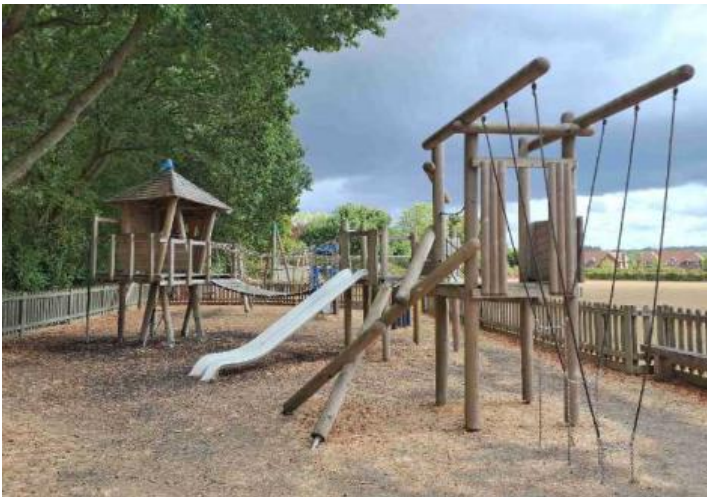
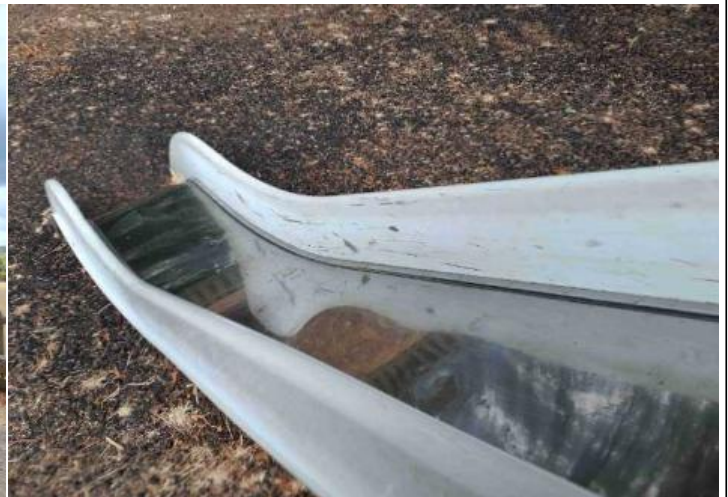
**Item:** Activity Equipment - Multi Play (Junior)  
**Manufacturer:** Eibe Play Ltd

**Finding:** There are a number of dents in the slide surface

**Action:** Monitor for any further deterioration and repair as required

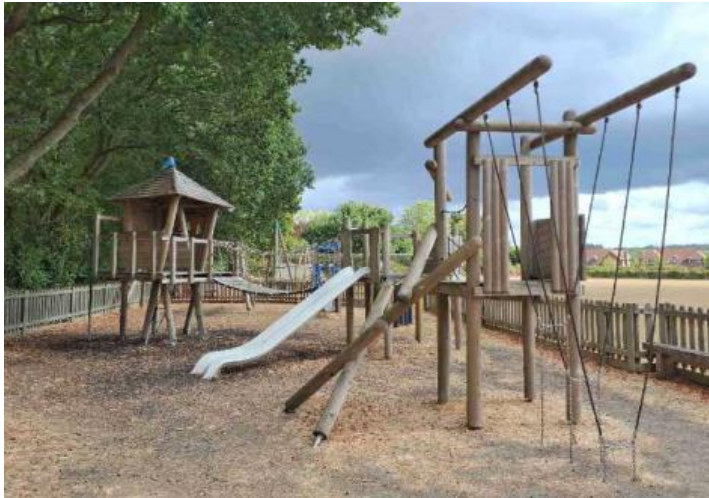
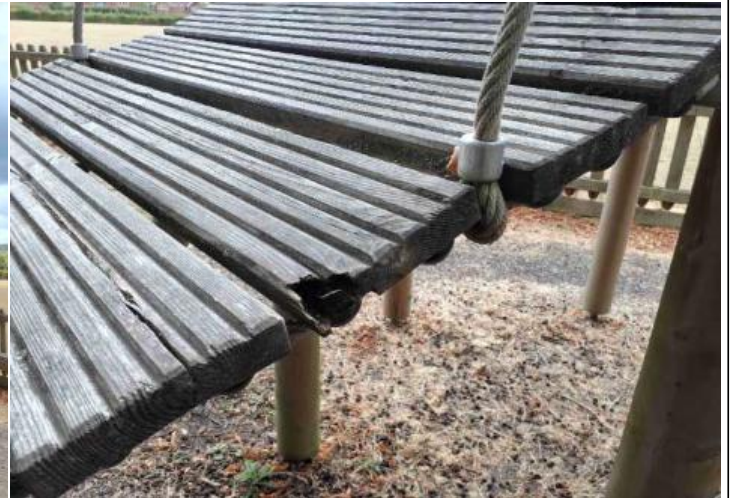
**Item:** Activity Equipment - Multi Play (Junior)  
**Manufacturer:** Eibe Play Ltd

**Finding:** There is some evidence of rot in the timber

**Action:** Monitor for any further deterioration and replace as required

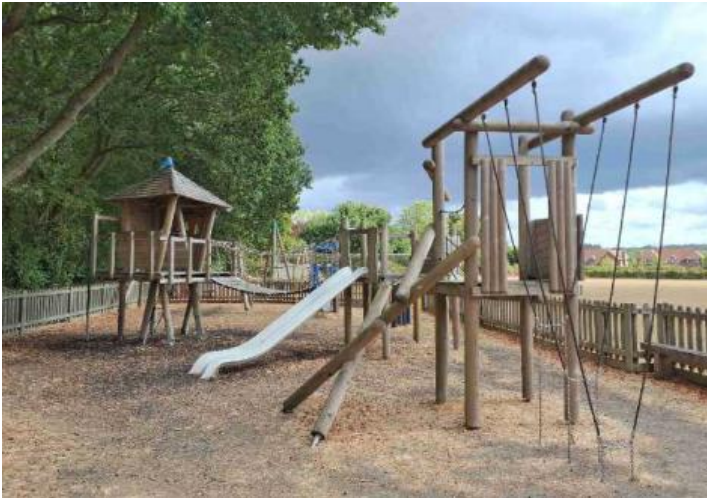
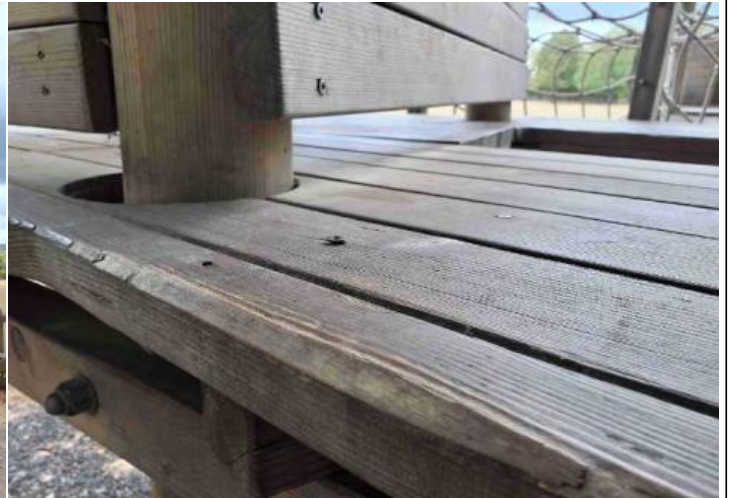
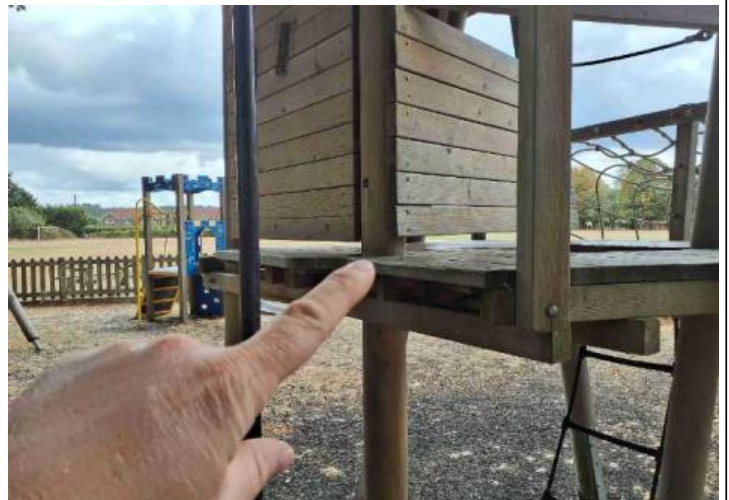
**Item:** Activity Equipment - Multi Play (Junior)  
**Manufacturer:** Eibe Play Ltd

**Finding:** A number of fixing(s) have worked loose

**Action:** Secure all loose fixings

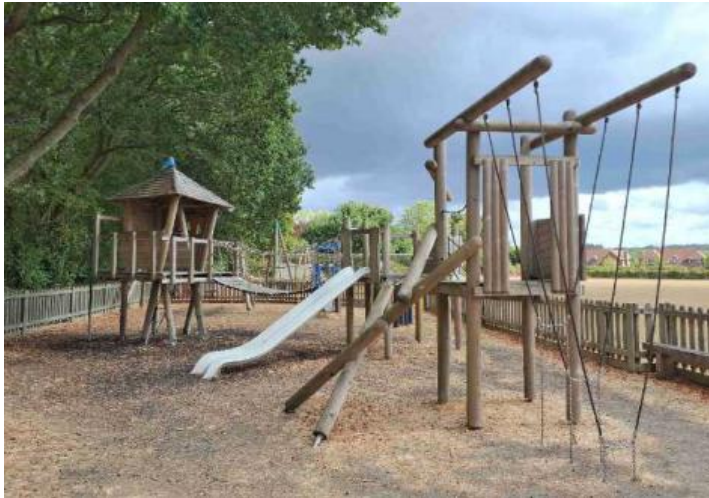
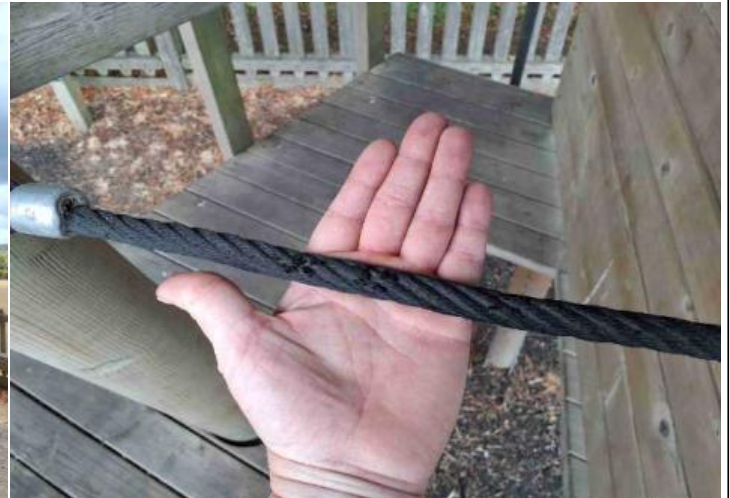
**Item:** Activity Equipment - Multi Play (Junior)  
**Manufacturer:** Eibe Play Ltd

**Finding:** The ropes/nets are worn/damaged in places

**Action:** Monitor for any further deterioration and repair or replace as required

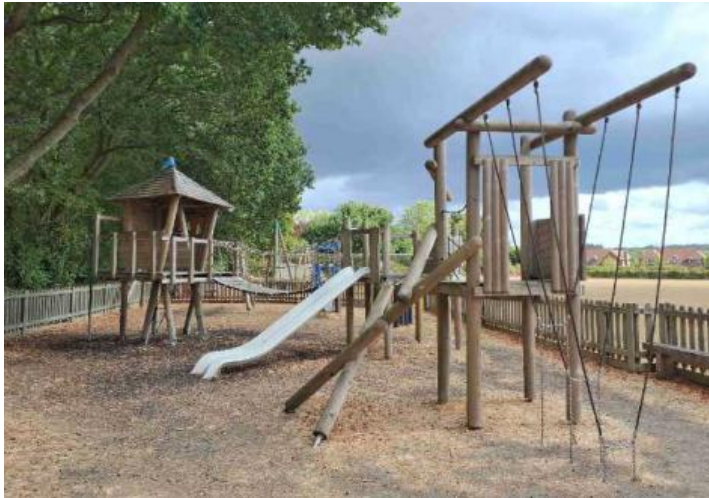
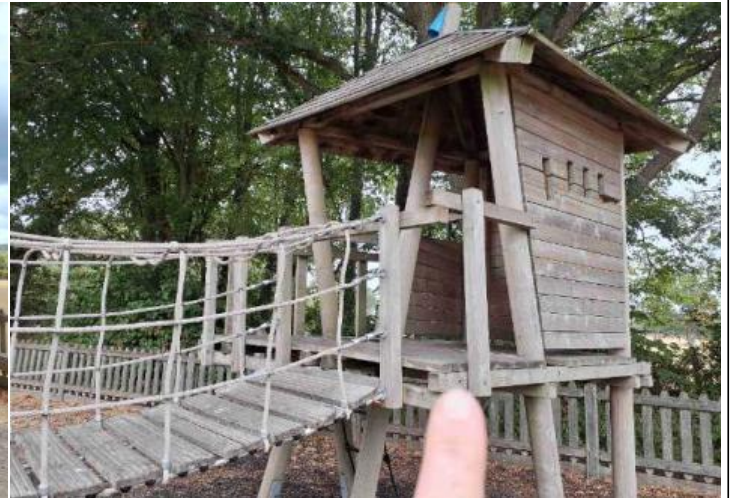
**Item:** Activity Equipment - Multi Play (Junior)  
**Manufacturer:** Eibe Play Ltd

**Finding:** A number of fixing(s) have worked loose on the guarding

**Action:** Secure all loose fixings

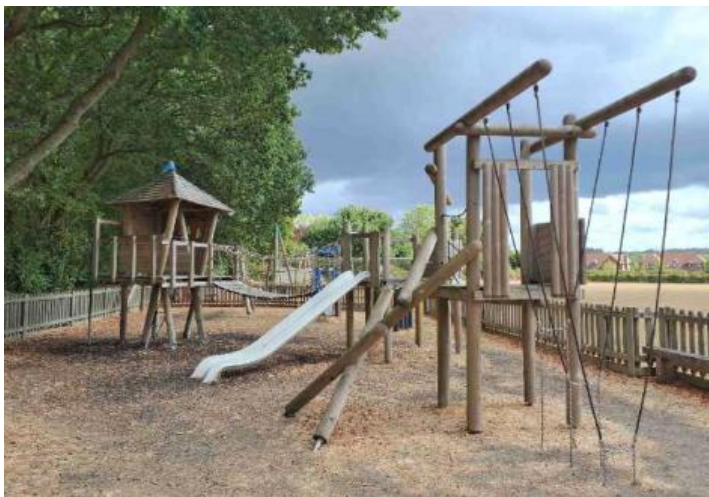
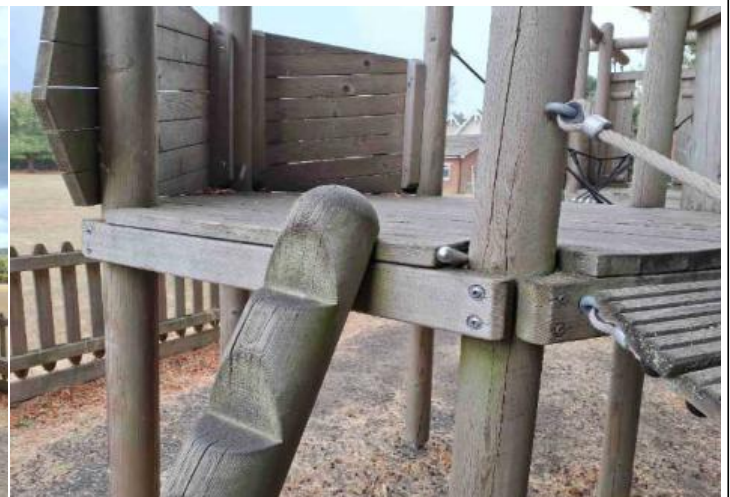
**Item:** Activity Equipment - Multi Play (Junior)  
**Manufacturer:** Eibe Play Ltd

**Finding:** There is/are finger entrapment/s in the platform and the item fails to meet the requirements of BS EN 1176 Part 1 4.2.7.6 Entrapment of fingers

**Action:** Monitor - No action given the risk assessment

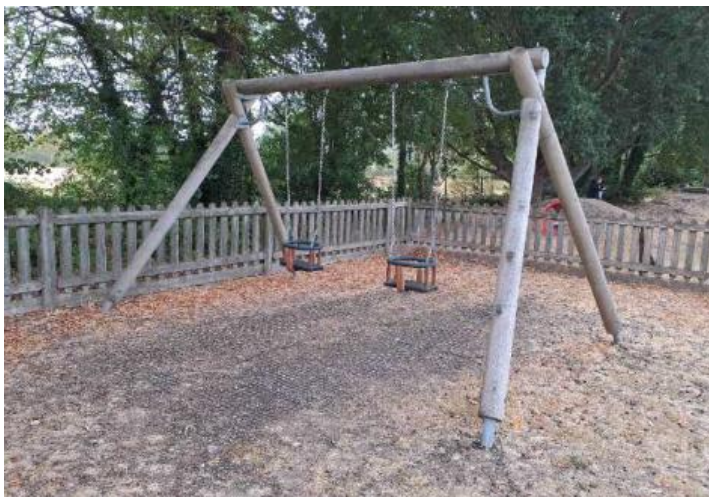
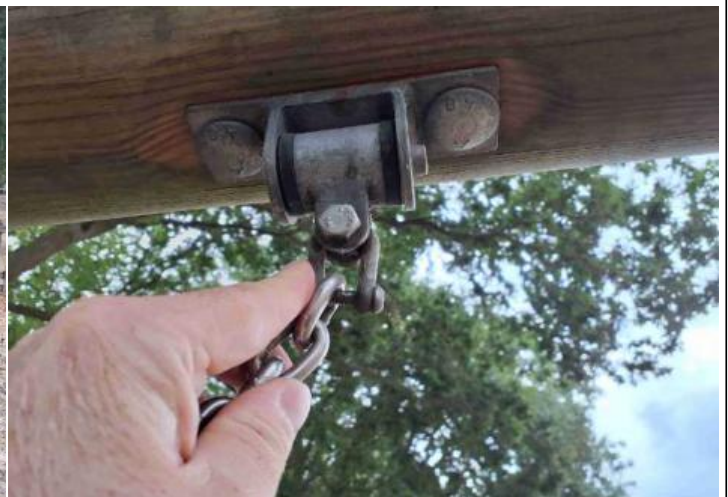
**Item:** Swings - 1 Bay 2 Seat (Cradle)  
**Manufacturer:** Eibe Play Ltd

**Finding:** There is some wear to the shackles.

**Action:** Monitor for any further deterioration and replace when 40% worn

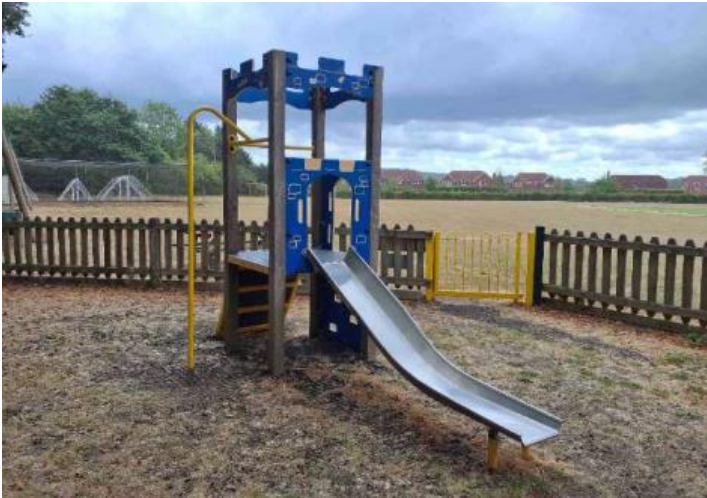
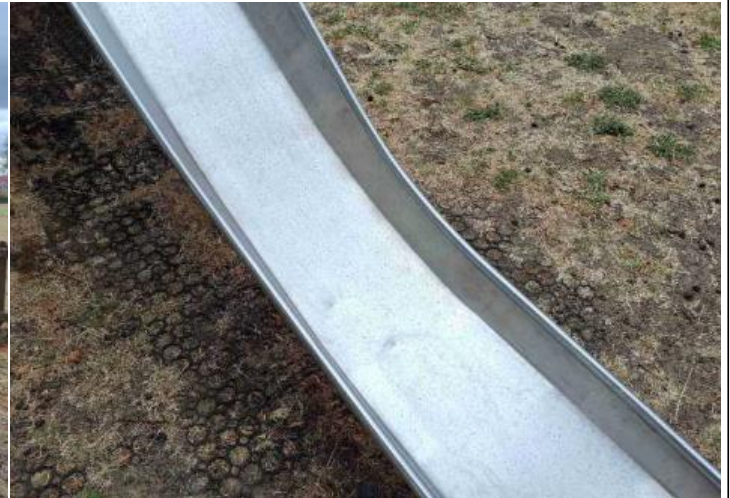
**Item:** Activity Equipment - Multi Play (Toddler)  
**Manufacturer:** Not Identified

**Finding:** There are a number of dents in the slide surface

**Action:** Monitor for any further deterioration and repair as required

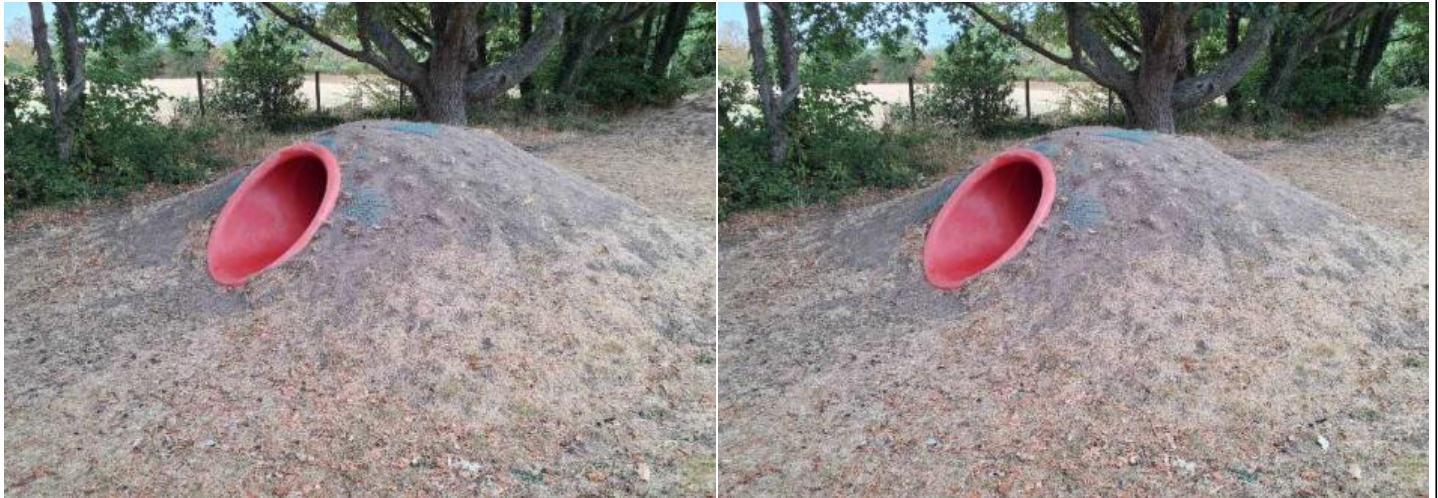
**Item:** Activity Equipment - Crawling Tunnel  
**Manufacturer:** Eibe Play Ltd

**Finding:** This design / configuration of tunnel mound is well established and has been successfully included in large quantities of playgrounds throughout the UK. Whilst the design does not fully meet the requirements of BS EN 1176 with regards to falls in excess of 600mm over the edge of the tunnel to the surface below, it has been risk assessed as fit for purpose in this regard and no changes are recommended to the design unless otherwise stated in additional findings

**Action:** Monitor - No action given the risk assessment

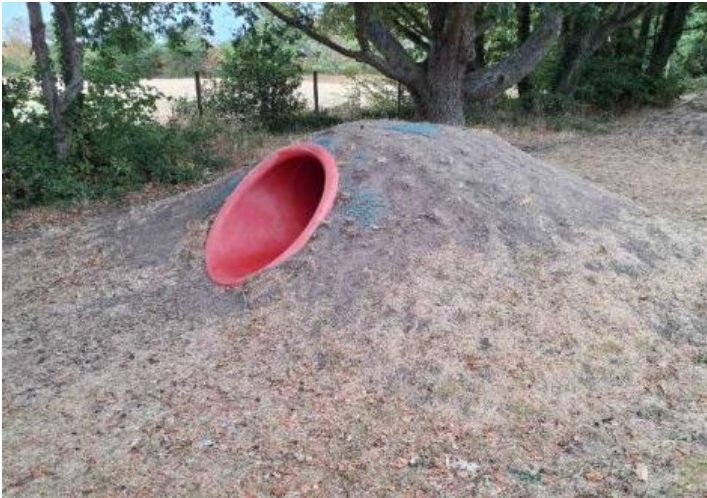
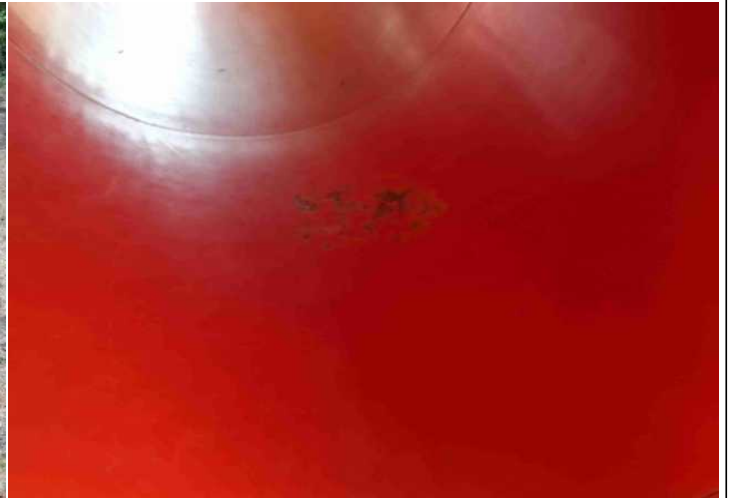
**Item:** Activity Equipment - Crawling Tunnel  
**Manufacturer:** Eibe Play Ltd

**Finding:** There is some evidence of fire damage to the item **Action:** Monitor for any further deterioration and repair as required

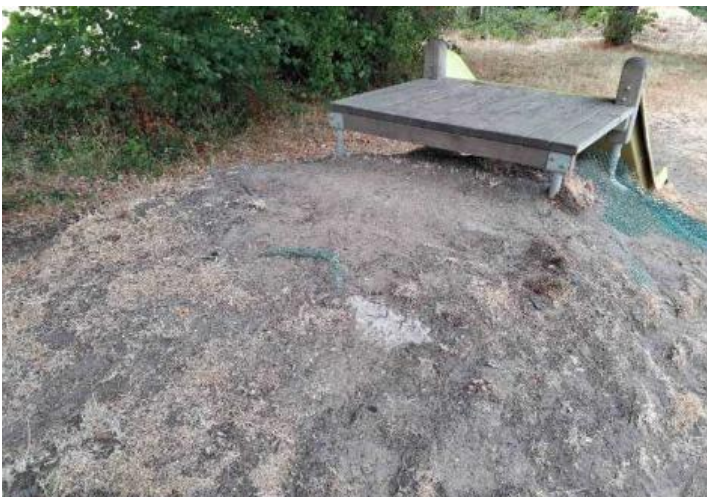
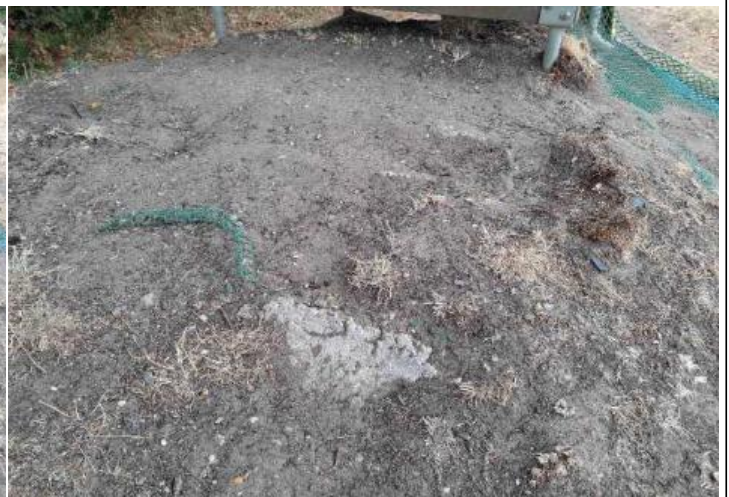
**Item:** Other - Tree Trunk  
**Manufacturer:** Natural Feature

**Finding:** The item has been removed leaving the foundations exposed **Action:** Remove the foundations and reinstate surface

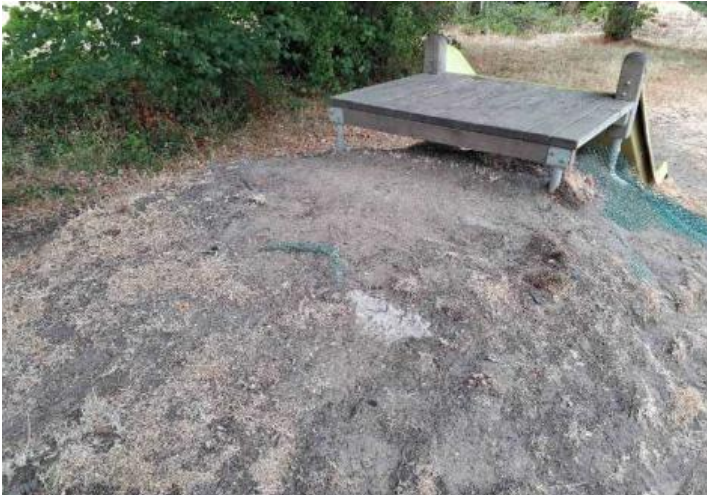
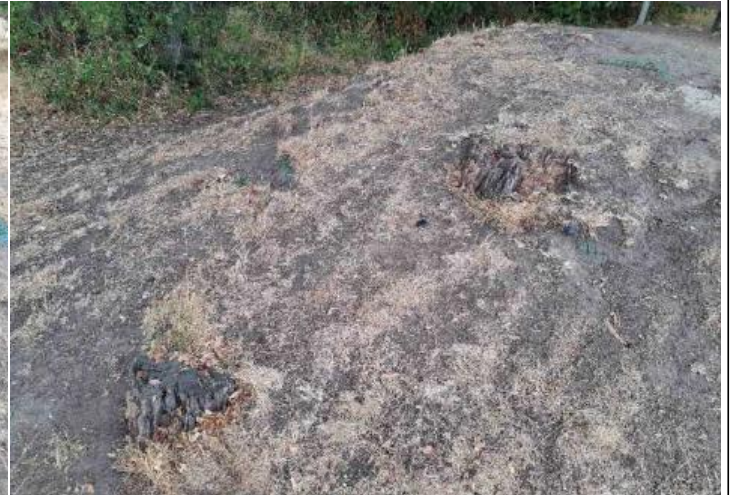
**Item:** Other - Tree Trunk  
**Manufacturer:** Natural Feature

**Finding:** There are areas or parts of the timber on the structure that have rotted

**Action:** Replace all affected timbers

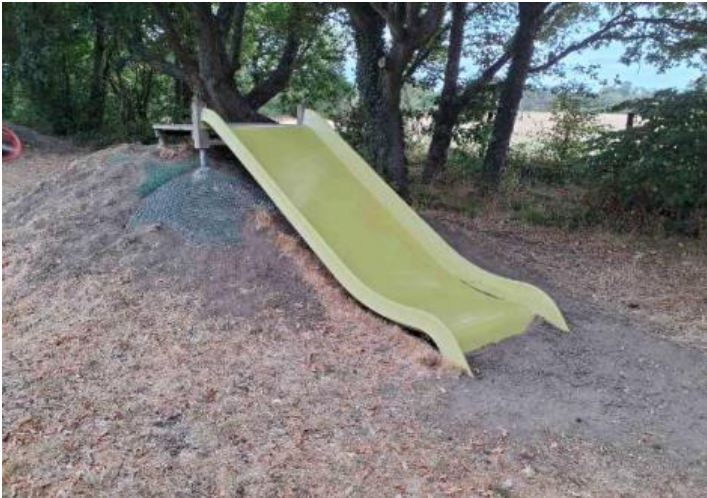
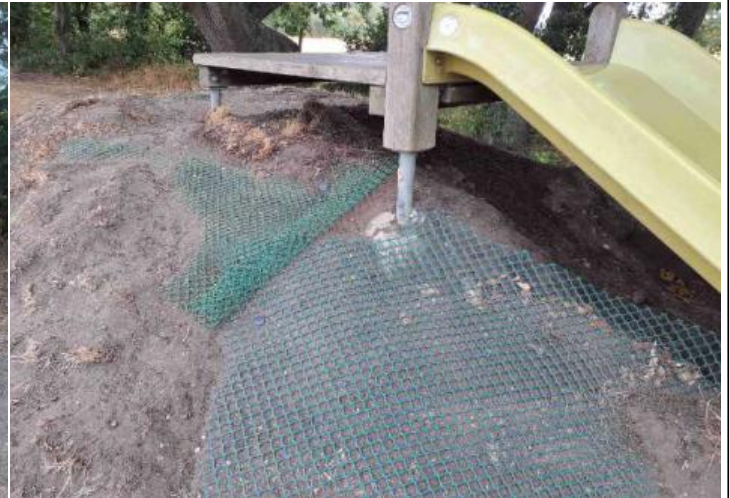
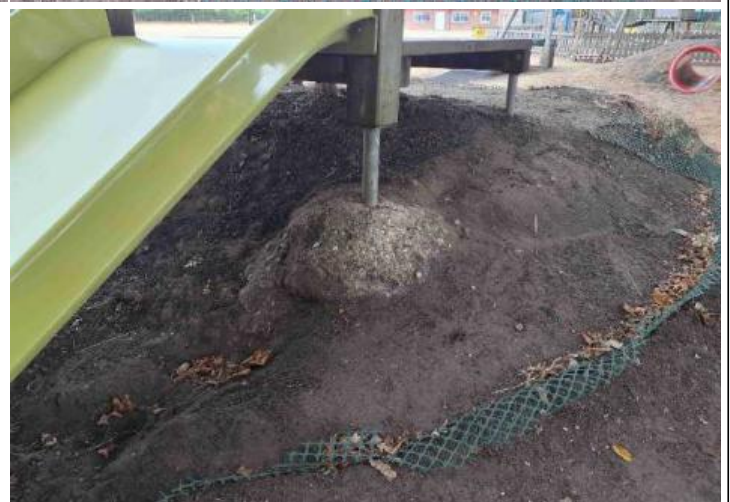
**Item:** Other - Embankment Slide  
**Manufacturer:** Eibe Play Ltd

**Finding:** The surface has eroded and the foundations are exposed

**Action:** Reinstall surrounding surfaces to cover the foundations
