## Annual Inspection

Bentley Parish Council

Bentley Recreation Ground

School Lane , GU10 5JP

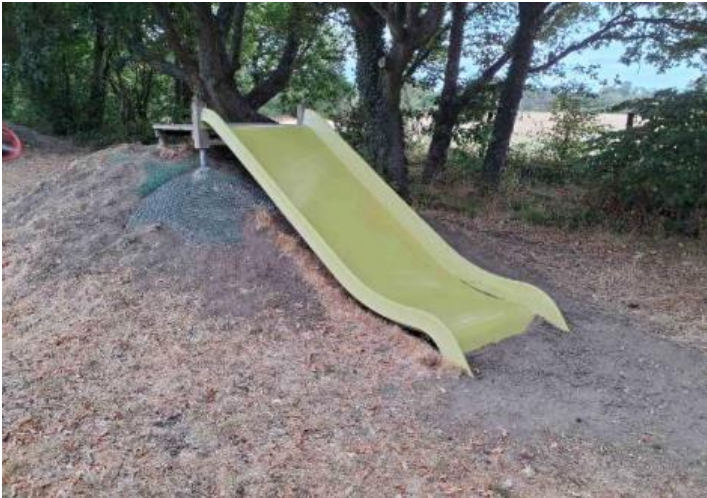
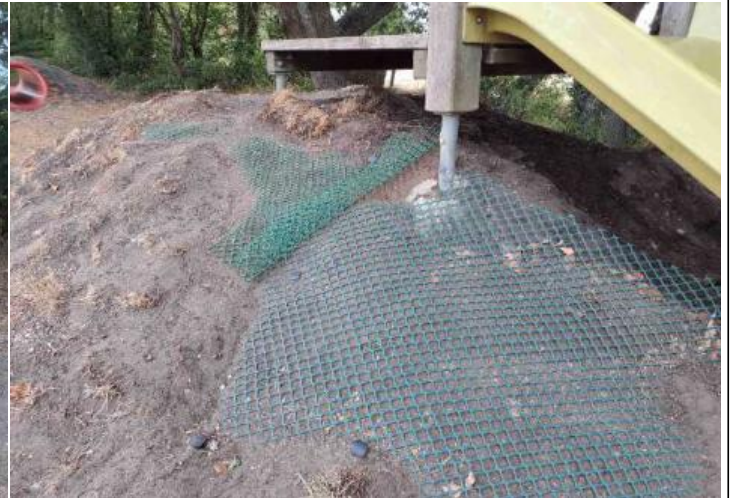
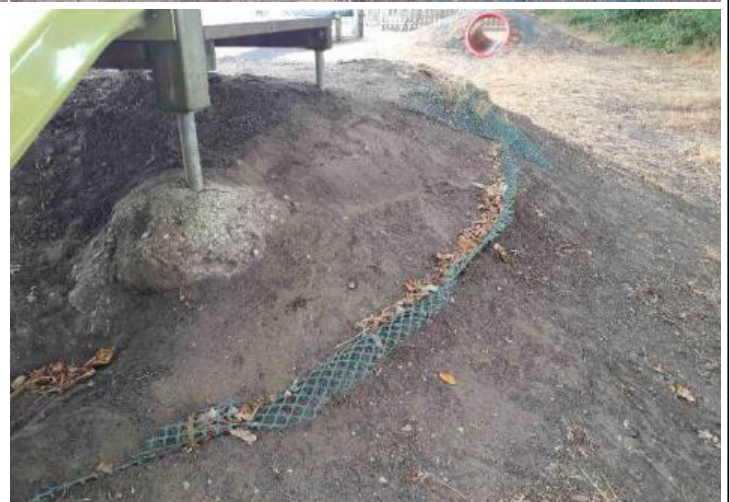
**Item:** Other - Embankment Slide  
**Manufacturer:** Eibe Play Ltd

**Finding:** There is moderate damage to the surface

**Action:** Repair the damaged areas of surfacing

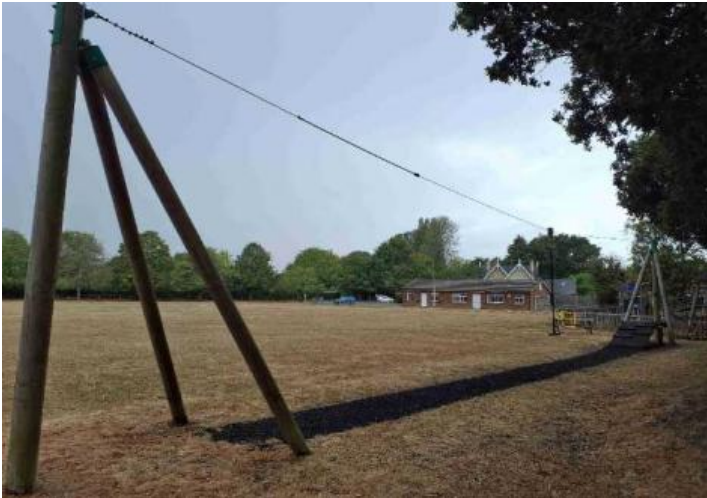
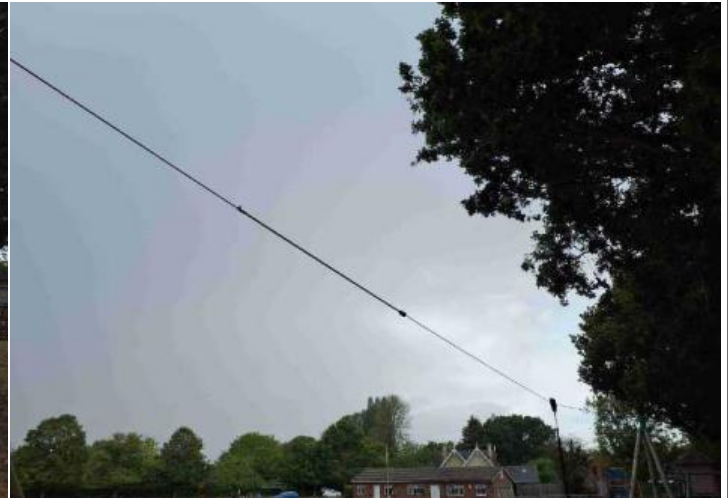
**Item:** Other - Cable Runway  
**Manufacturer:** A.E.Evans

**Finding:** We have completed a visual inspection of the suspension links, cable and fixing points from ground level, however it is not possible to fully inspect these areas without either hiring equipment to gain access or removing the cable and suspension and inspecting at ground level. We recommend that the main cable and fixing security is thoroughly inspected at least in accordance with the manufacturers recommendations to check for wear, damage, security or internal rusting; this will help to ensure the continued safe use of the equipment

**Action:** Inspect in accordance with the manufacturers recommendations

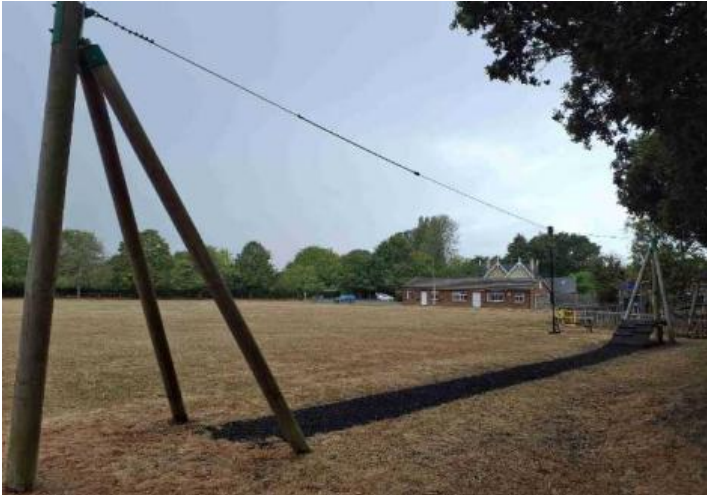
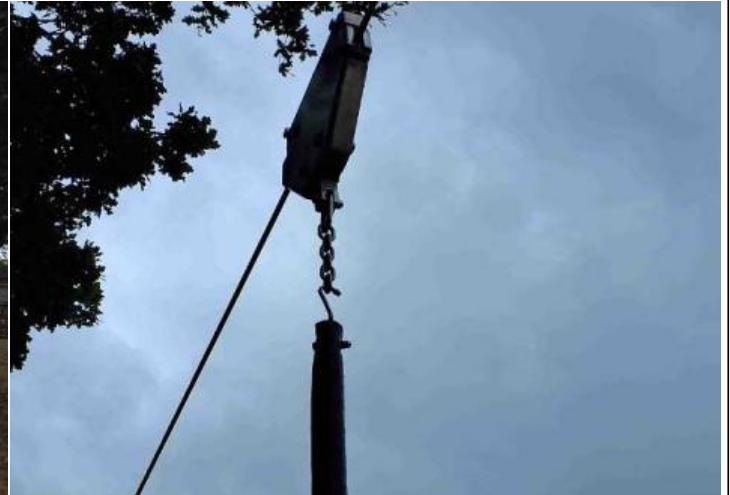
**Item:** Other - Cable Runway  
**Manufacturer:** A.E.Evans

**Finding:** The item has been severely damaged

**Action:** Repair or replace the item / affected part

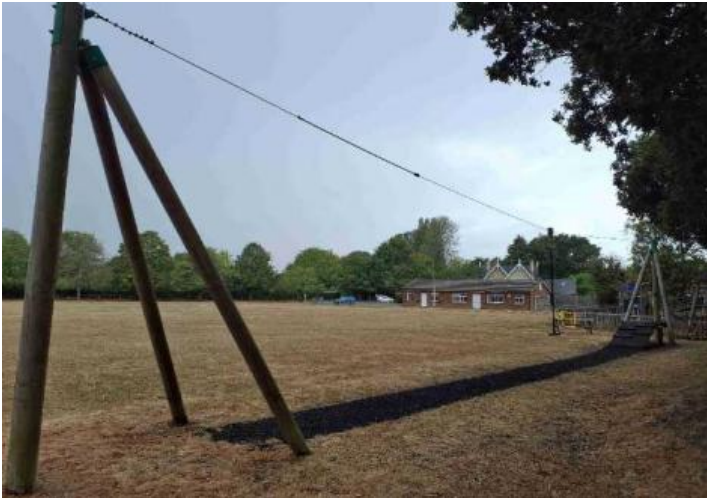
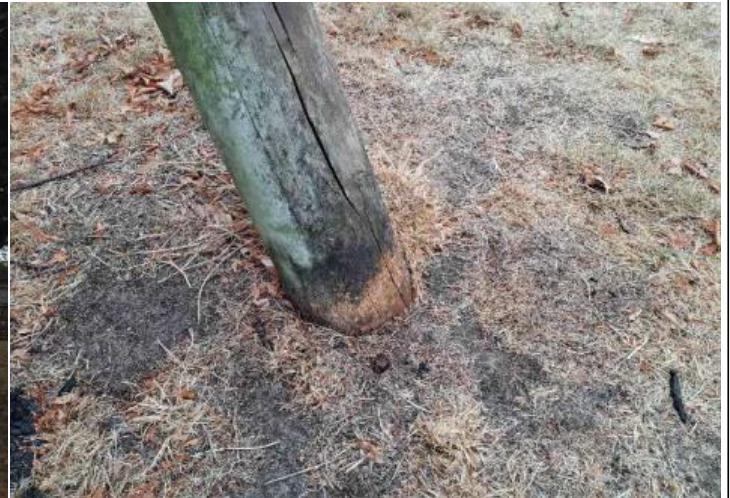
**Item:** Other - Cable Runway  
**Manufacturer:** A.E.Evans

**Finding:** There is some strimmer / machinery damage apparent on the posts, this can penetrate the preservative applied to the timber and accelerate the rotting process

**Action:** Monitor for any deterioration (rot) and replace as required

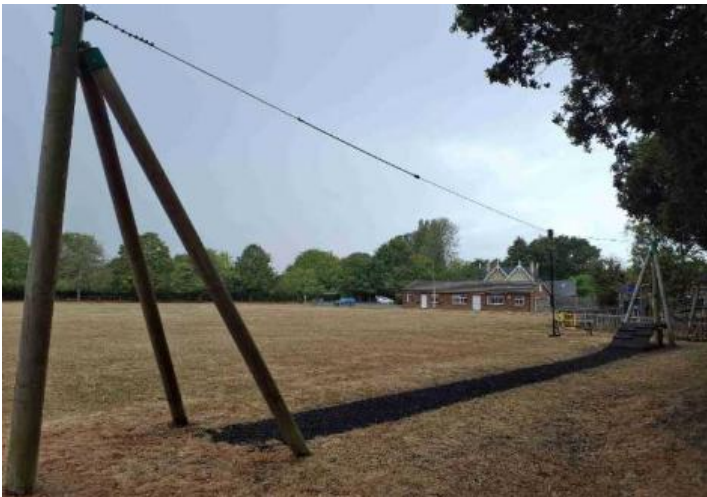
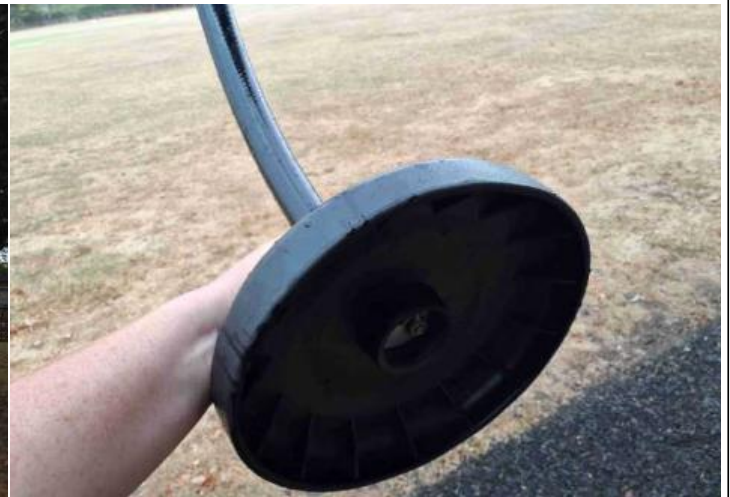
**Item:** Other - Cable Runway  
**Manufacturer:** A.E.Evans

**Finding:** The seat connection cannot be inspected without dismantling the seat

**Action:** Dismantle the seat to inspect the seat connection for wear
