## Annual Inspection

Bentley Parish Council

Bentley Recreation Ground

School Lane , GU10 5JP

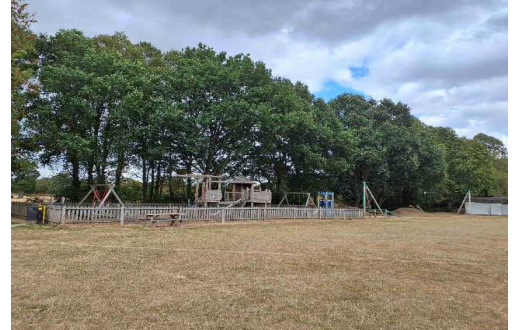
There is some tree debris on the surfacing - Remove and maintain

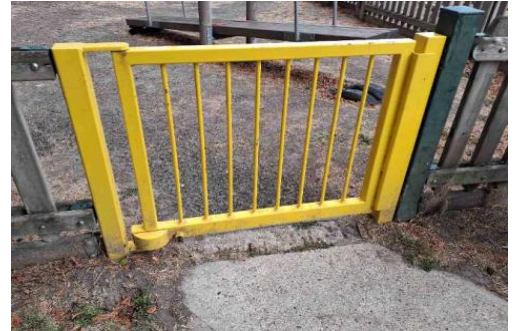
The gate is closing too quickly (less than 4 seconds) - Take corrective action to ensure that the gate closes in 4-8 seconds from 90 degrees

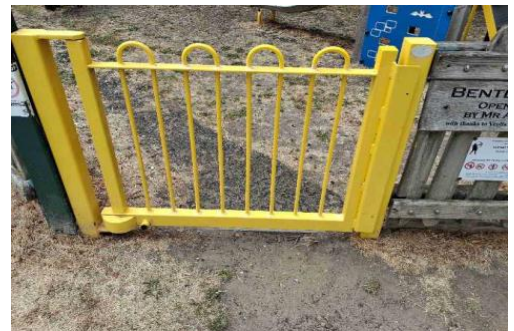
The gate is closing too quickly (less than 4 seconds) - Take corrective action to ensure that the gate closes in 4-8 seconds from 90 degrees

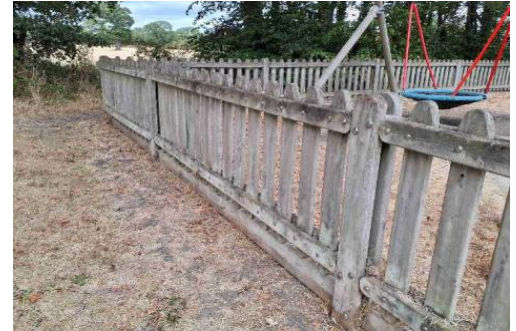
There are a number of loose posts around the fence -  
 Monitor for any further deterioration and reset as required

There are areas or parts of the timber posts that have rotted  
 - Replace all affected timbers

There is or are fixings missing on the item - Replace all  
 missing fixings

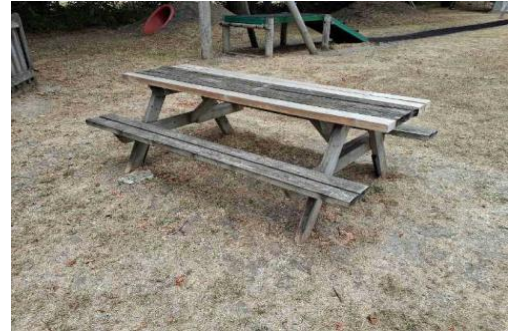
The surface has eroded and the foundations are exposed - Reinstate surrounding surfaces to cover the foundations

There is some evidence of rot in the timber - Monitor for any further deterioration and replace as required

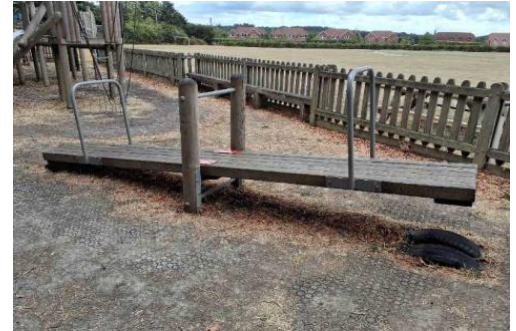
A number of fixing(s) have worked loose - Secure all loose fixings

The surface has subsided around the tyre dampeners - Monitor for any further deterioration and repair as required

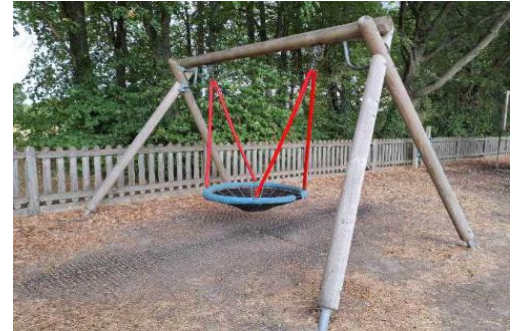
The seat connection cannot be inspected fully as the chain cover cannot be lifted - Cut the cover to allow access to the shackle and assess the wear

The bush / bushes is / are showing signs of wear - Monitor for any further deterioration and replace as required

The ropes/nets are worn/damaged in places - Monitor for any further deterioration and repair or replace as required

The seat has minor damage or wear - Monitor for any further deterioration and replace as required

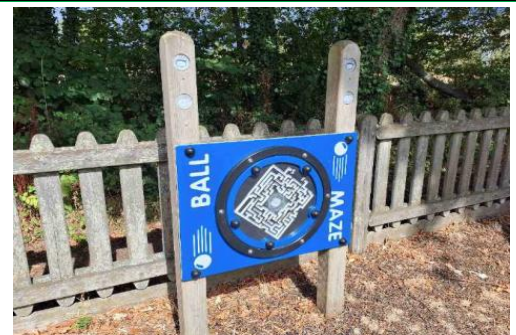
The item has been damaged - Monitor for any further deterioration and replace as required

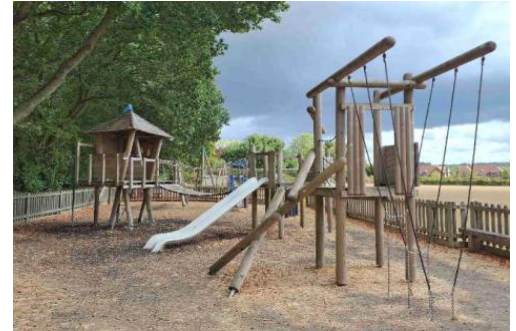
The use of synthetic fillers in timber is not recommended; timber being a natural material will expand and contract as the moisture content changes and the use of fillers can exacerbate the length and depth of these cracks or shakes in the timber. The only treatment that is normally required is the removal of any rough or sharp edges unless the structural integrity of the item is affected. - Remove any rough or sharp edges and monitor timber for any further deterioration

The timber has a number of splits/shakes or air cracks and this may affect the stability or allow water ingress which will accelerate the rotting process. Timber splits may also create rough / splintering edges. - Monitor, sand down any rough edges and ensure the splits do not cross through fixing points of the structure and/or cause any instability

There is some evidence of rot in the timber - Monitor for any further deterioration and replace as required

The ropes/nets are worn/damaged in places - Monitor for any further deterioration and repair or replace as required

A number of fixing(s) have worked loose on the guarding - Secure all loose fixings

A number of fixing(s) have worked loose - Secure all loose fixings

There are a number of dents in the slide surface - Monitor for any further deterioration and repair as required

There is/are finger entrapment/s in the platform and the item fails to meet the requirements of BS EN 1176 Part 1 4.2.7.6 Entrapment of fingers - Monitor - No action given the risk assessment

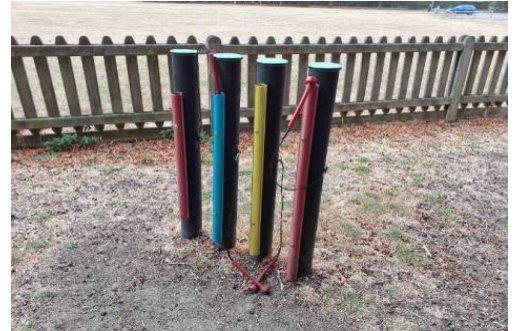
The area around the item has eroded and may become slippery - Reinststate eroded area

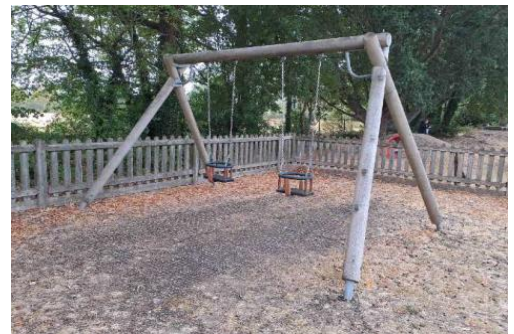
There is some wear to the shackles. - Monitor for any further deterioration and replace when 40% worn

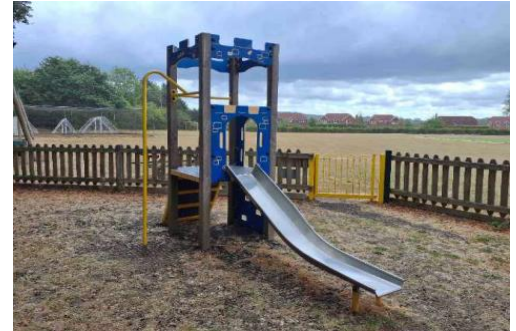
There are a number of dents in the slide surface - Monitor for any further deterioration and repair as required

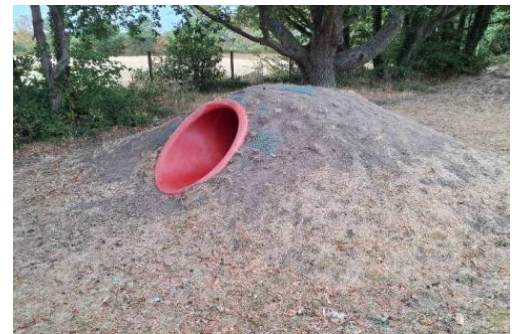
This design / configuration of tunnel mound is well established and has been successfully included in large quantities of playgrounds throughout the UK. Whilst the design does not fully meet the requirements of BS EN 1176 with regards to falls in excess of 600mm over the edge of the tunnel to the surface below, it has been risk assessed as fit for purpose in this regard and no changes are recommended to the design unless otherwise stated in additional findings - Monitor - No action given the risk assessment

There is some evidence of fire damage to the item - Monitor for any further deterioration and repair as required

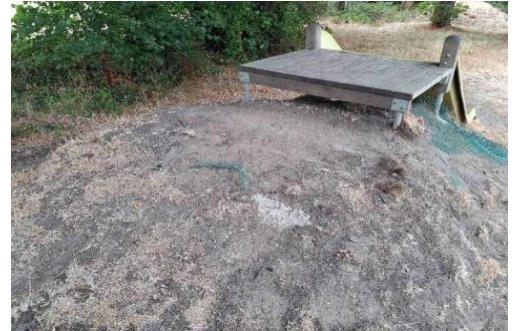
The item has been removed leaving the foundations exposed - Remove the foundations and reinstate surface

There are areas or parts of the timber on the structure that have rotted - Replace all affected timbers

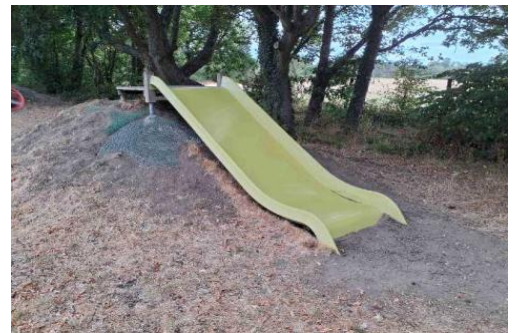
The surface has eroded and the foundations are exposed - Reinstate surrounding surfaces to cover the foundations

There is moderate damage to the surface - Repair the damaged areas of surfacing

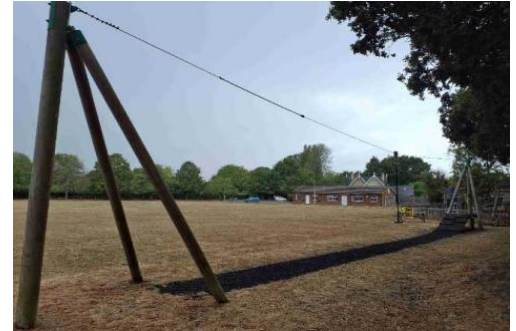
We have completed a visual inspection of the suspension links, cable and fixing points from ground level, however it is not possible to fully inspect these areas without either hiring equipment to gain access or removing the cable and suspension and inspecting at ground level. We recommend that the main cable and fixing security is thoroughly inspected at least in accordance with the manufacturers recommendations to check for wear, damage, security or internal rusting; this will help to ensure the continued safe use of the equipment - Inspect in accordance with the manufacturers recommendations

The seat connection cannot be inspected without dismantling the seat - Dismantle the seat to inspect the seat connection for wear

The item has been severely damaged - Repair or replace the item / affected part

There is some strimmer / machinery damage apparent on the posts, this can penetrate the preservative applied to the timber and accelerate the rotting process - Monitor for any deterioration (rot) and replace as required

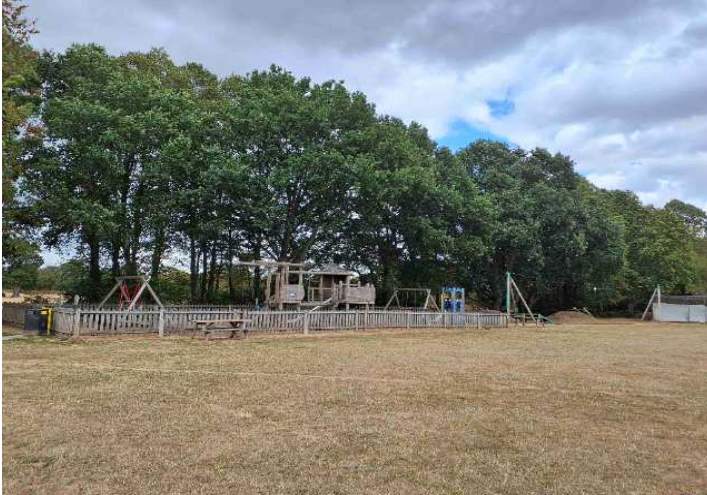
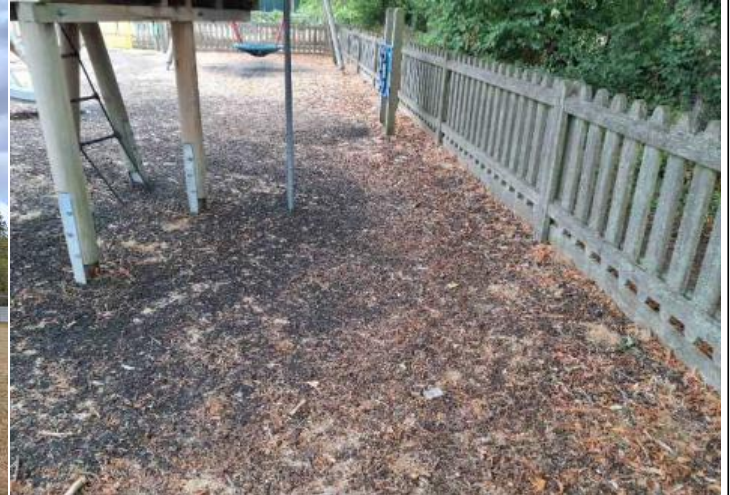
**Finding:** There is some tree debris on the surfacing

**Action:** Remove and maintain

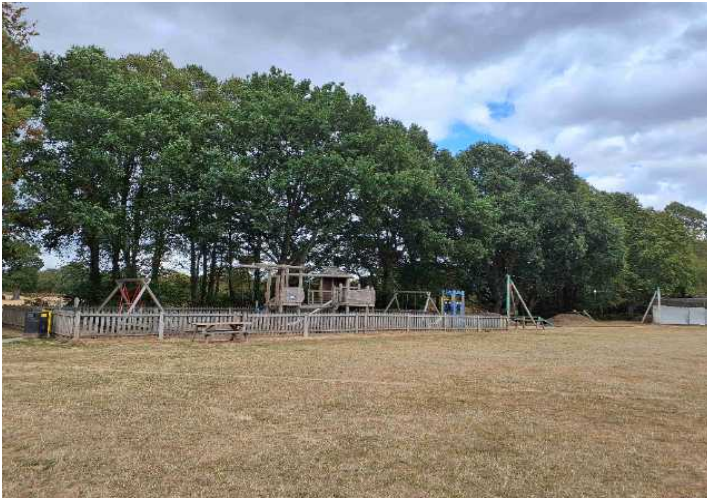
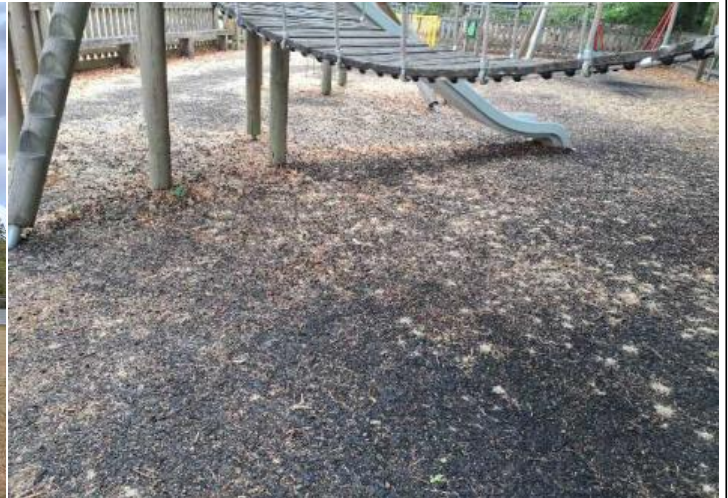
**Finding:** There is weed / vegetation growth within the surface

**Action:** Remove weed / vegetation growth

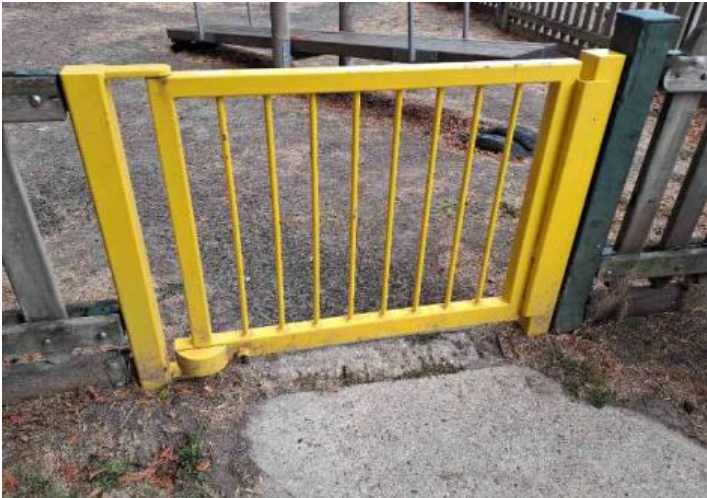
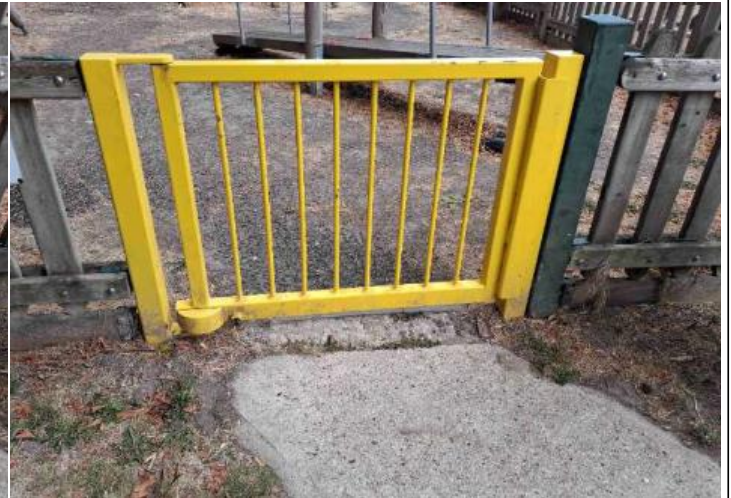
**Finding:** The gate is closing too quickly (less than 4 seconds)

**Action:** Take corrective action to ensure that the gate closes in 4-8 seconds from 90 degrees

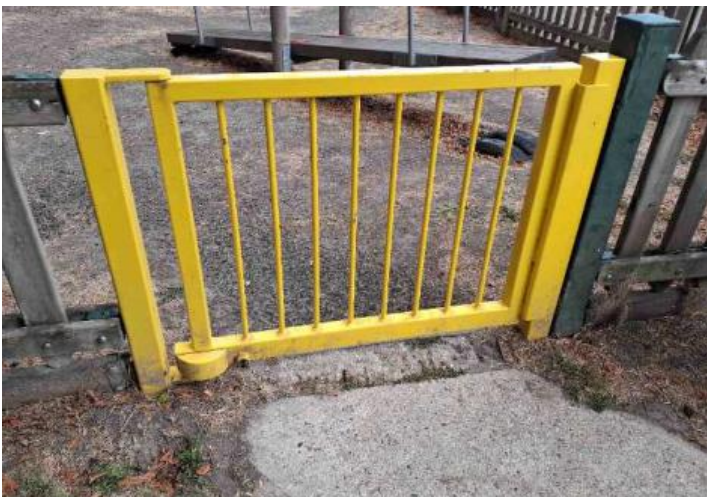
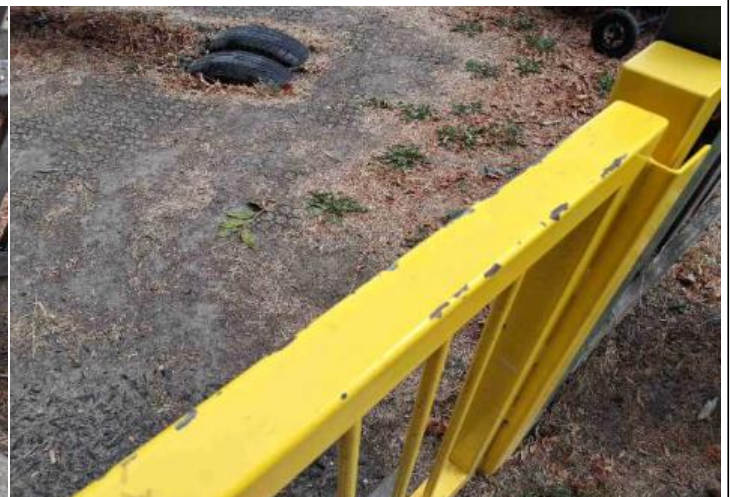
**Finding:** The paint is flaking off the metalwork

**Action:** Rub down and re-paint

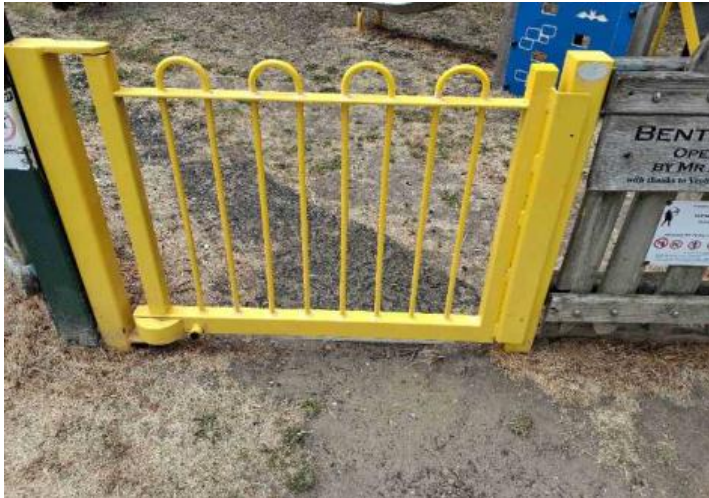
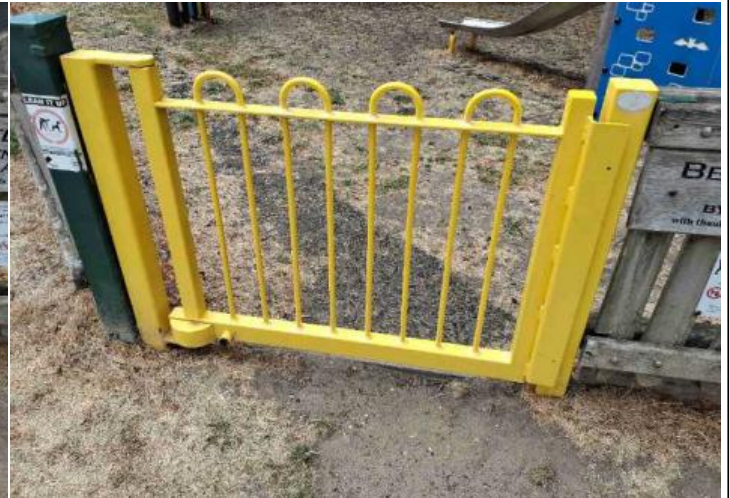
**Finding:** The gate is closing too quickly (less than 4 seconds)

**Action:** Take corrective action to ensure that the gate closes in 4-8 seconds from 90 degrees

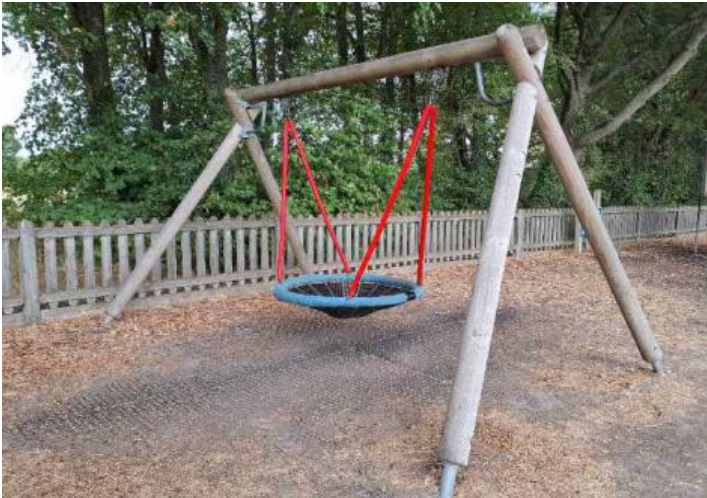
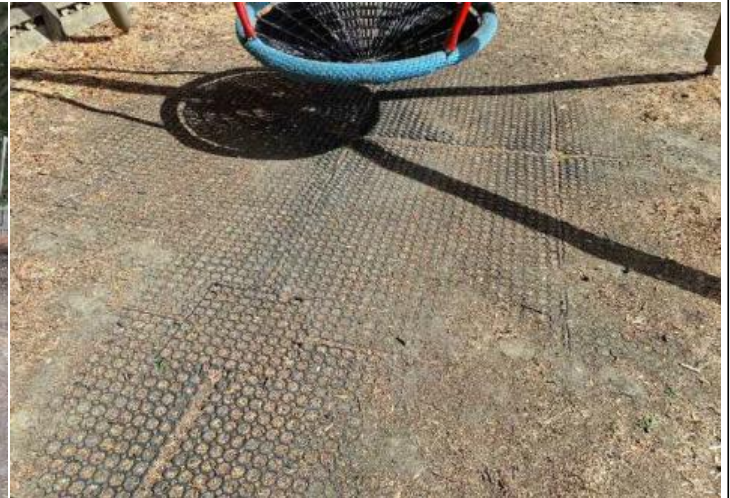
**Finding:** The grass mats are silted up, the soil is compacted and the area will become very slippery when the soil is wet. **Action:** Reinstate as required

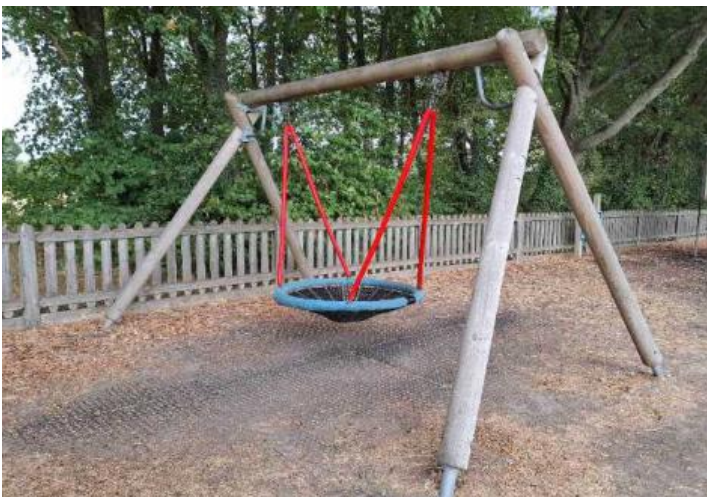
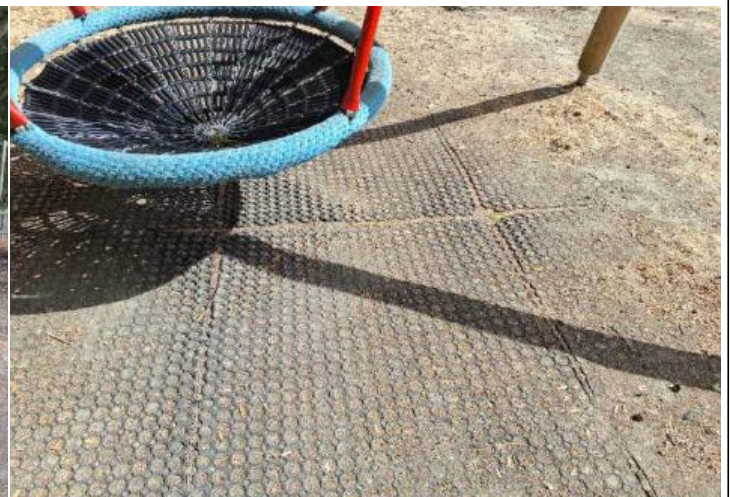
**Finding:** There are gaps opening between the grass mat tiles **Action:** Provide additional ties or secure / reinstate surface

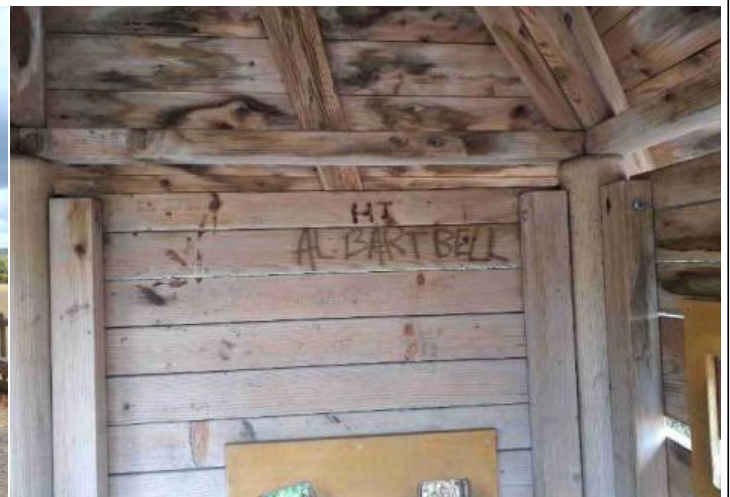
**Finding:** There is some graffiti present

**Action:** Remove the graffiti

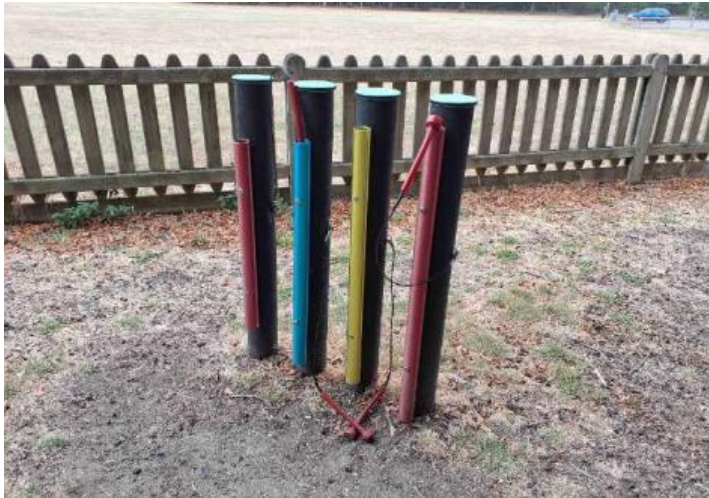
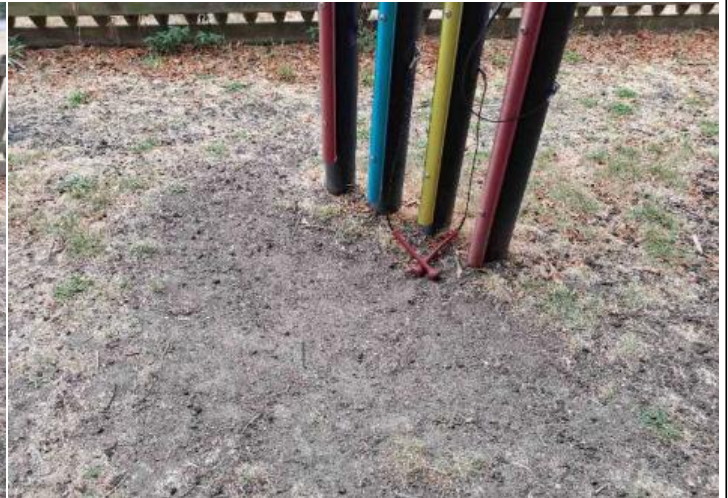
**Item:** Other - Musical Instrument  
**Manufacturer:** Not Identified

**Finding:** The area around the item has eroded and may become slippery

**Action:** Reinststate eroded area

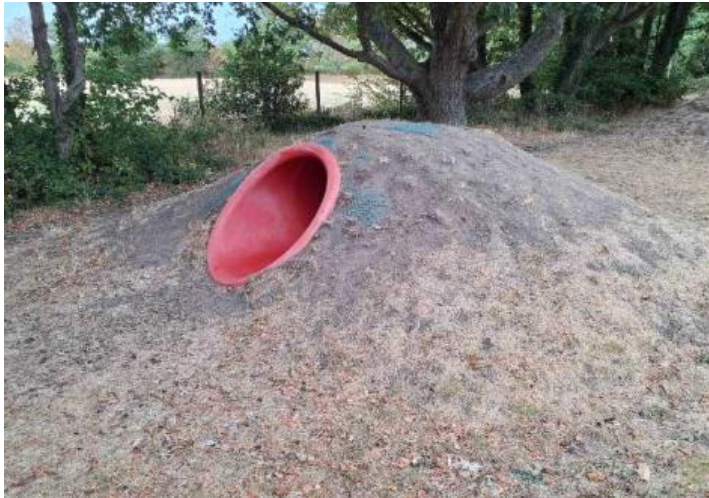
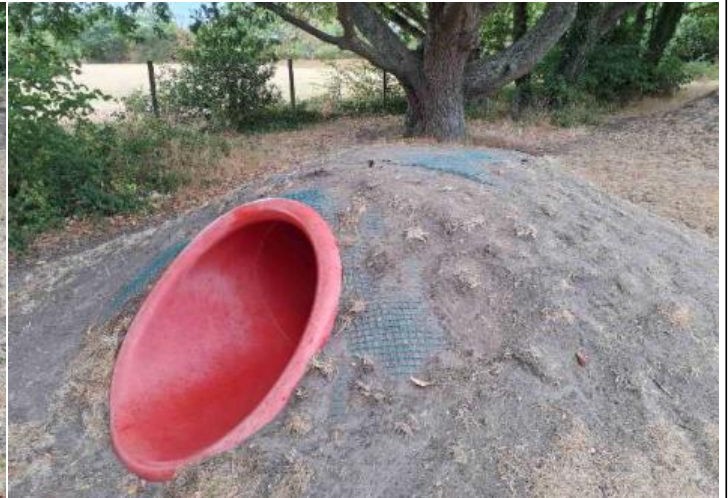
**Item:** Activity Equipment - Crawling Tunnel  
**Manufacturer:** Eibe Play Ltd

**Finding:** The grass has eroded within the impact area of the equipment and may not provide the necessary impact attenuating properties for the equipment fall height; the surface may also be slippery in wet weather  
**Action:** Reinstate the grass or provide an all weather surface

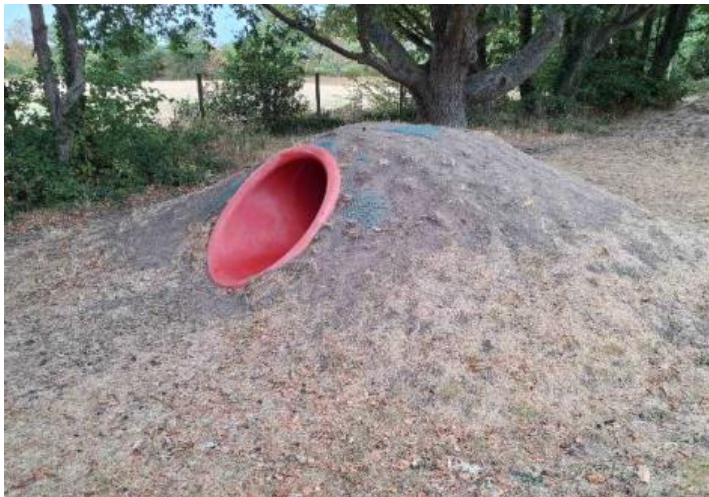
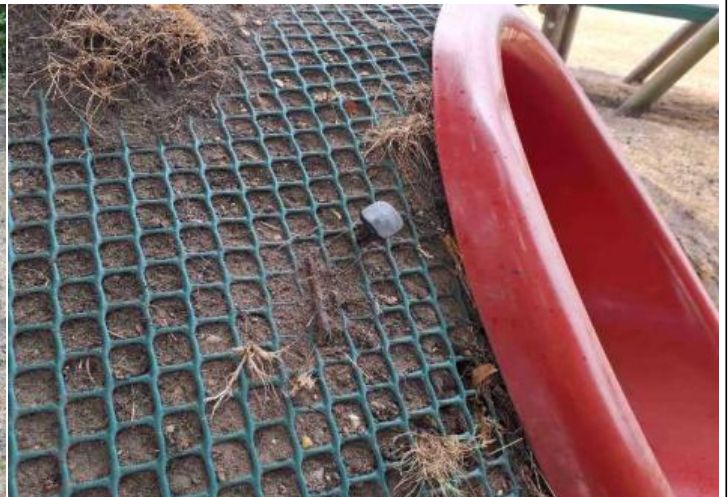
**Item:** Activity Equipment - Crawling Tunnel  
**Manufacturer:** Eibe Play Ltd

**Finding:** There are projecting grass mat pins present  
**Action:** Remove and provide more appropriate fixings if required

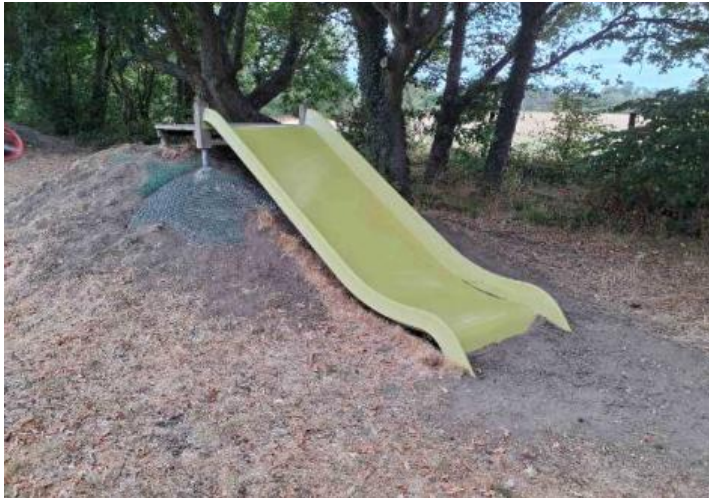
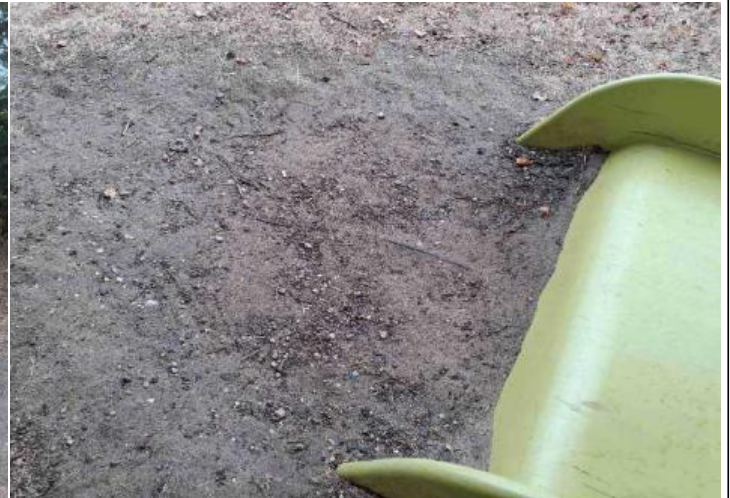
**Item:** Other - Embankment Slide  
**Manufacturer:** Eibe Play Ltd

**Finding:** The grass mat surfacing has numerous stones present within the surface and will not perform as intended in relation to Head Injury Criterion testing

**Action:** Lift mats and ensure stones are removed and ground is suitable prior to re-laying

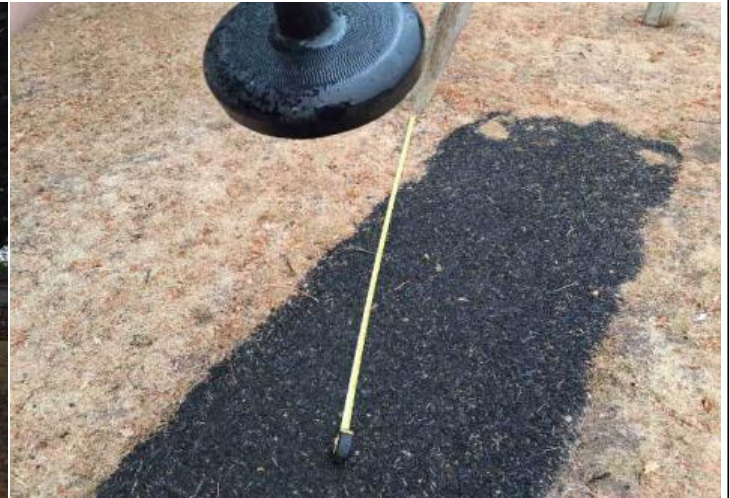
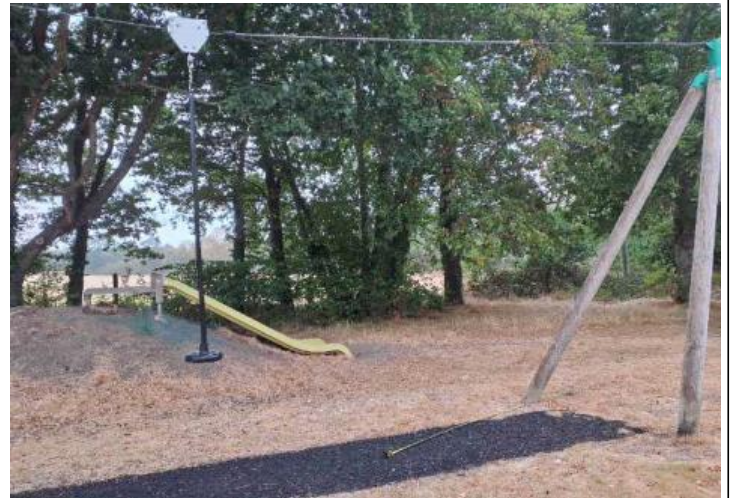
**Item:** Other - Cable Runway  
**Manufacturer:** A.E.Evans

**Finding:** The seat is less than 2.0 metres from the post when extended at 45 degrees at the end of the area of travel and does not meet the requirements of BS EN 1176 Part 4

**Action:** Adjust the cable stop position to ensure the minimum distance is maintained

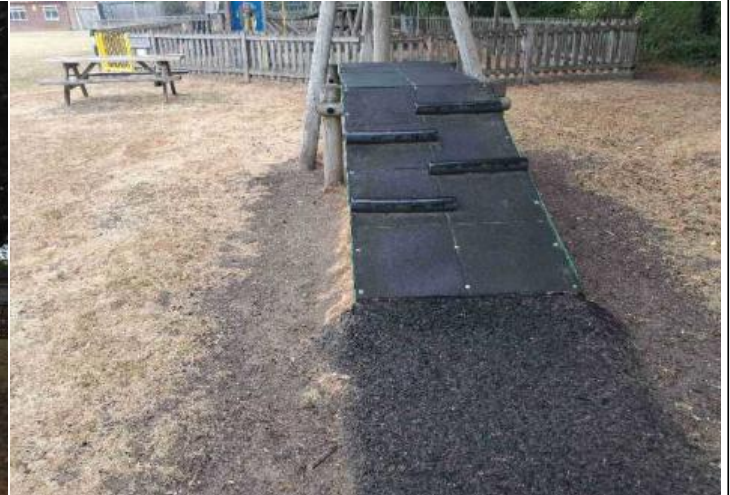
**Item:** Other - Cable Runway  
**Manufacturer:** A.E.Evans

**Finding:** The grass has eroded within the impact area of the equipment and may not provide the necessary impact attenuating properties for the equipment fall height; the surface may also be slippery in wet weather  
**Action:** Reinstate the grass or provide an all weather surface

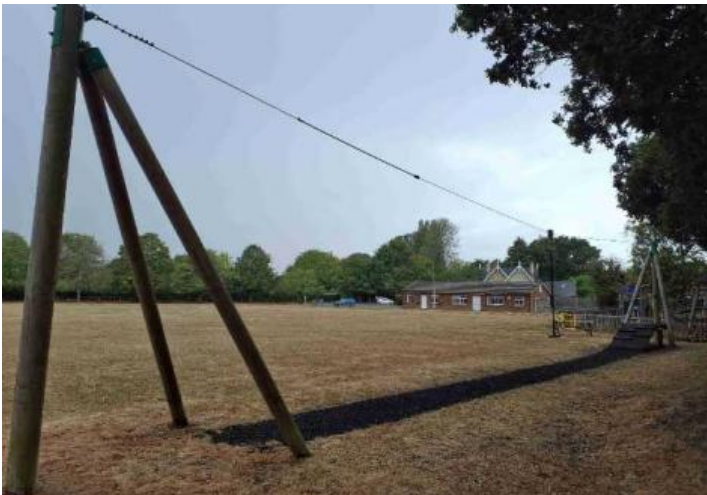
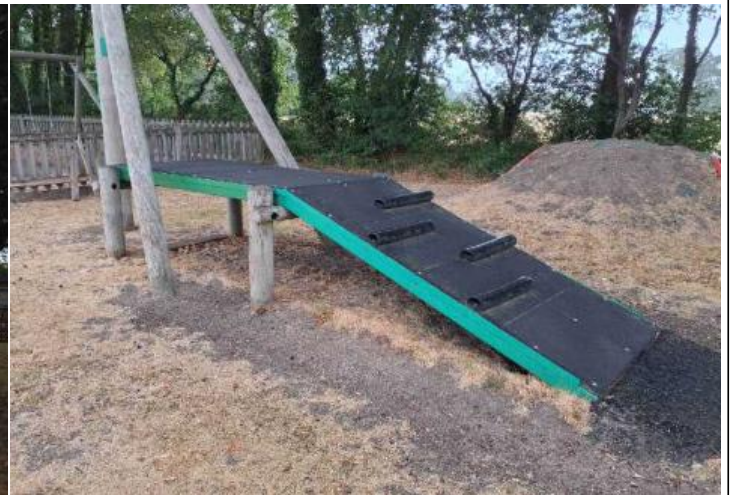
**Item:** Other - Cable Runway  
**Manufacturer:** A.E.Evans

**Finding:** The unit is easily accessible and should have the appropriate barriers installed to meet the requirements of BS EN 1176 Part 1 as the height of the unit exceeds 600mm  
**Action:** Monitor - No action given the risk assessment
